UPDATE FIVE

Well here is the next installment of the continuing saga of trying to resurrect a Passive Maser.

This Maser was one built under a Hughes Aircraft Company project the "Earthbased Compact Hydrogen Maser" circa 1985.

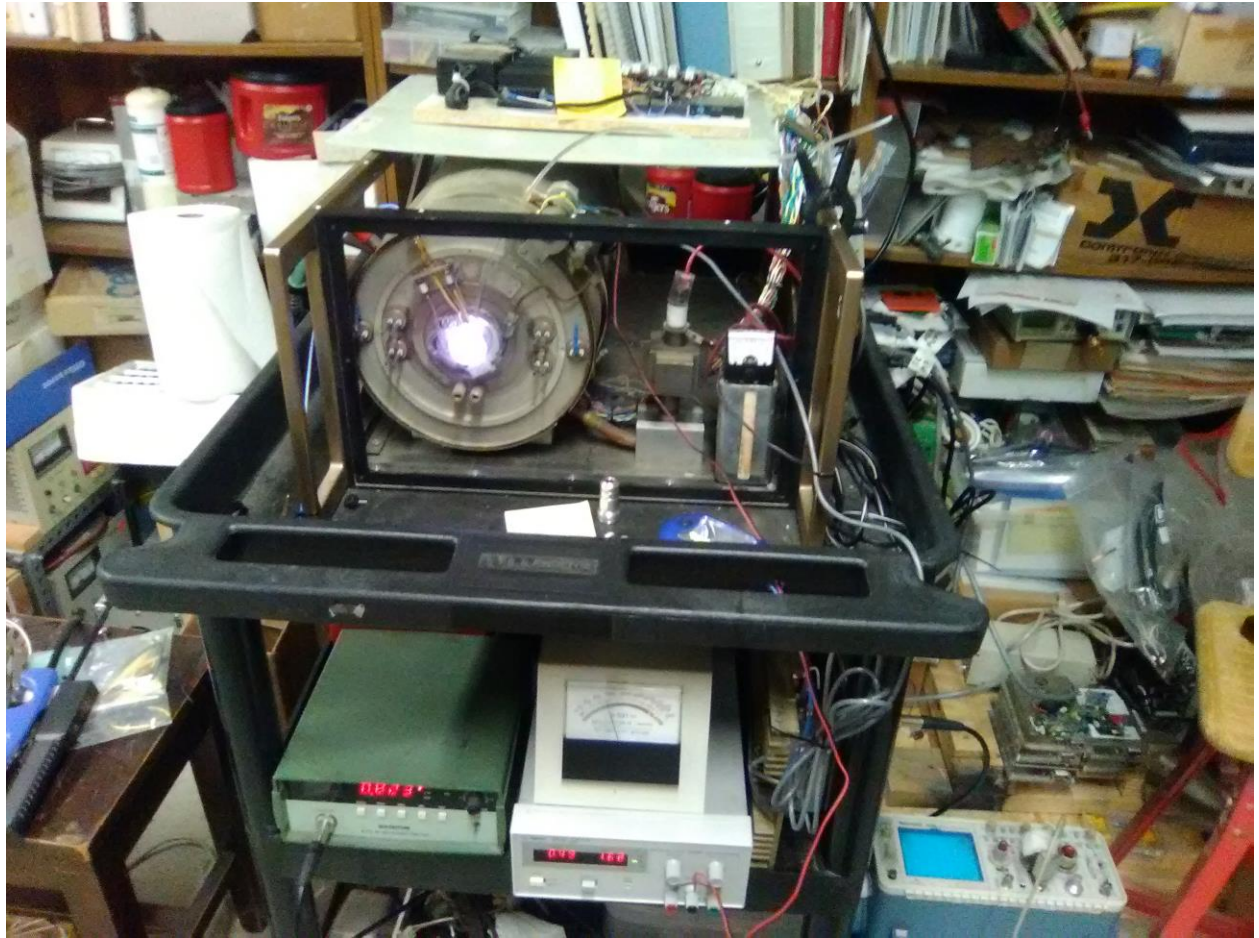
Built an RF generator to drive the dissociator and got some "glow", however the color was not quite right. A handheld spectrometer did show the 3 visible atomic Hydrogen Balmer lines but also showed the "continuum" of molecular Hydrogen.

DISSOCIATOR LIT

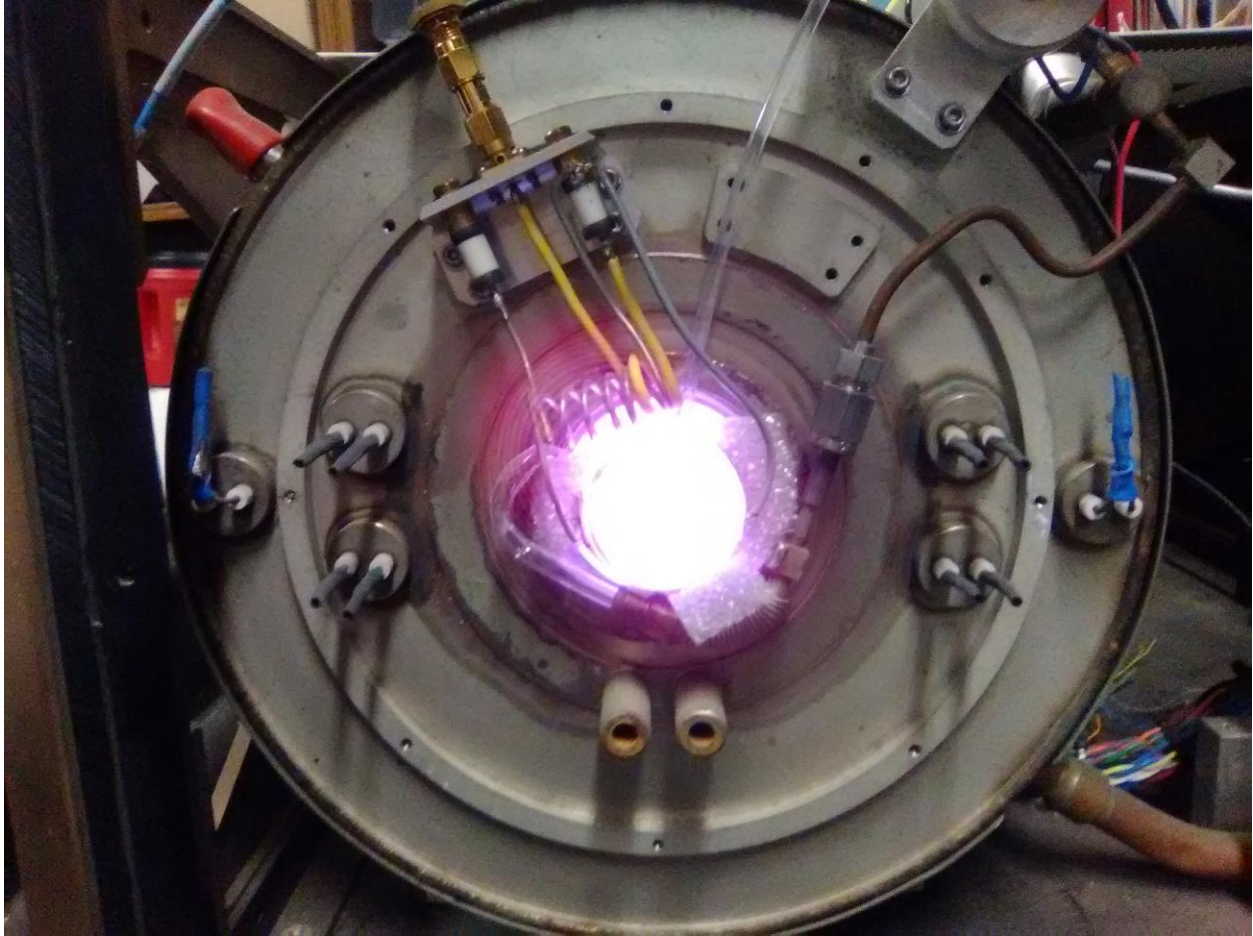
After two weeks of running, the spectrum did not improve.

DISSOCIATOR GLOW

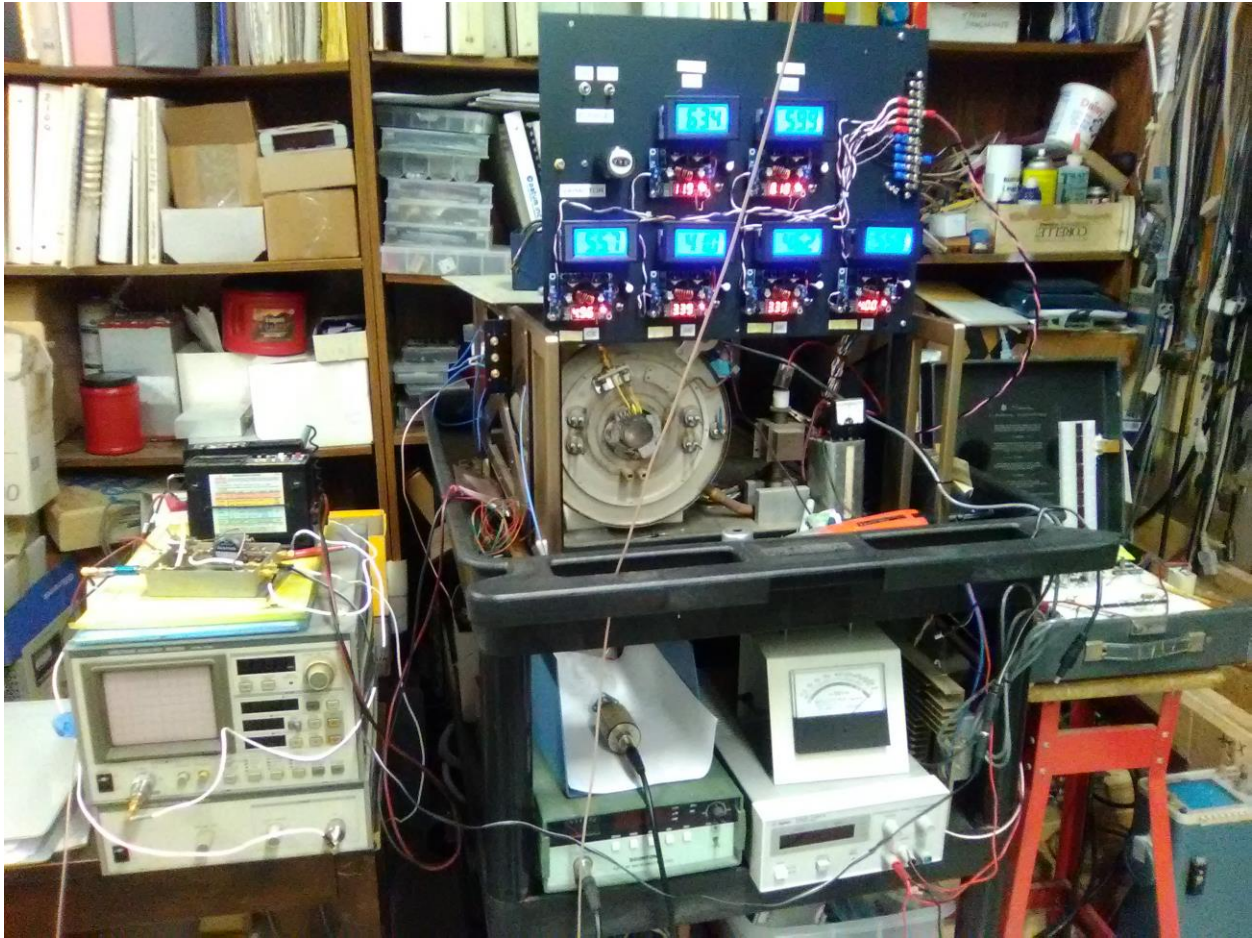
Hooked up the 6 ovens, a spec-A with a tracking generator, and an RF generator at 1420.405751 Mhz.

Got the cavity up to temp but when I tried to adjust the temp and varactor for the line frequency I found that the cavity was over 1Mhz off! Subsequent troubleshooting revealed the Major show stopper of a shorted cavity varactor diode!

HEATER AND RF SWEEP

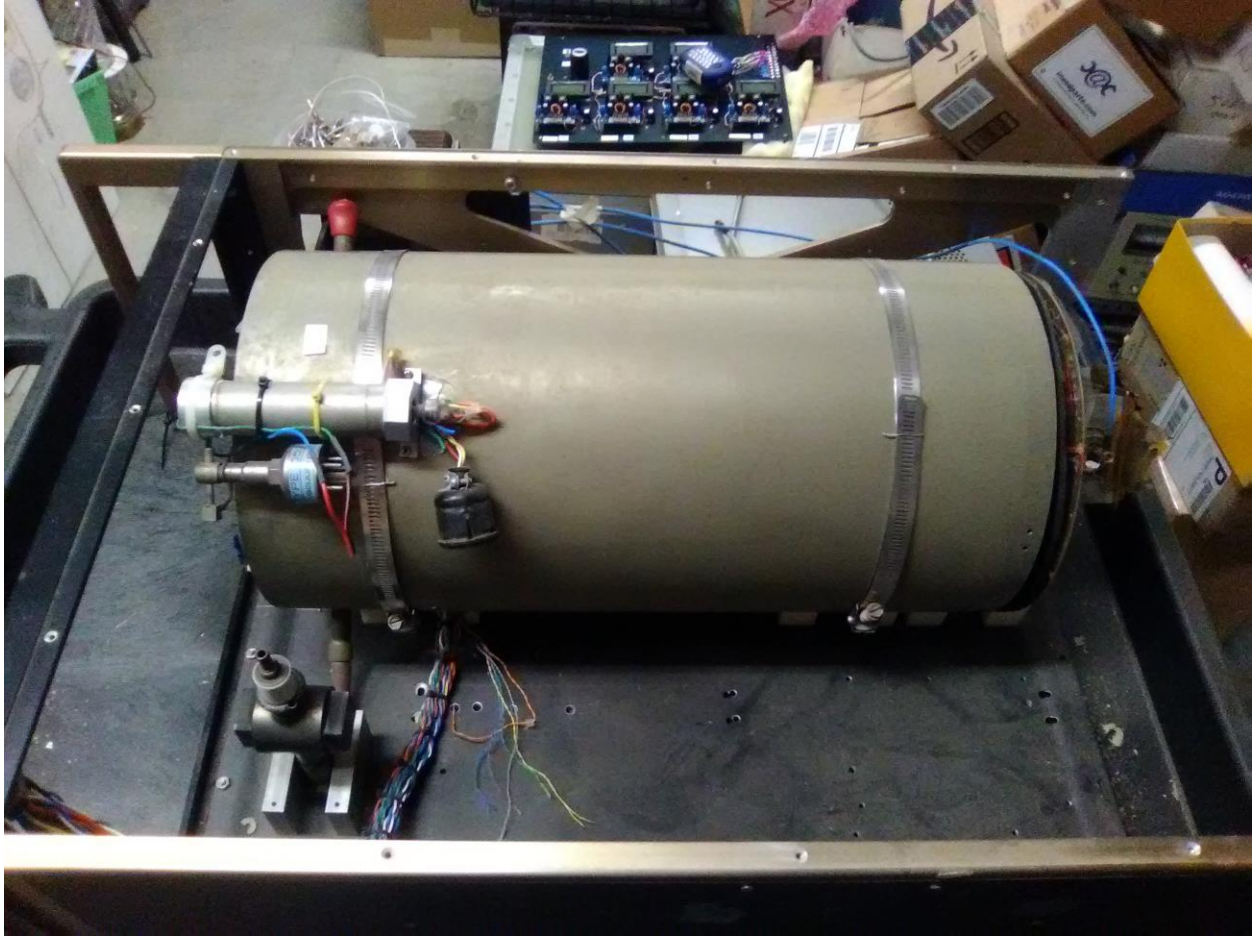
Unfortunately the "all welded titanium construction" of the vacuum envelope meant that getting it apart would require much cutting.

I knew that once it was opened "up to air" the getter pump assemblies would be ruined and also that the dissociator envelope appeared to be visibly contaminated.

So since I did not have to worry about those items the decision was made to cut the whole assembly off.

READY TO START TEAR DOWN

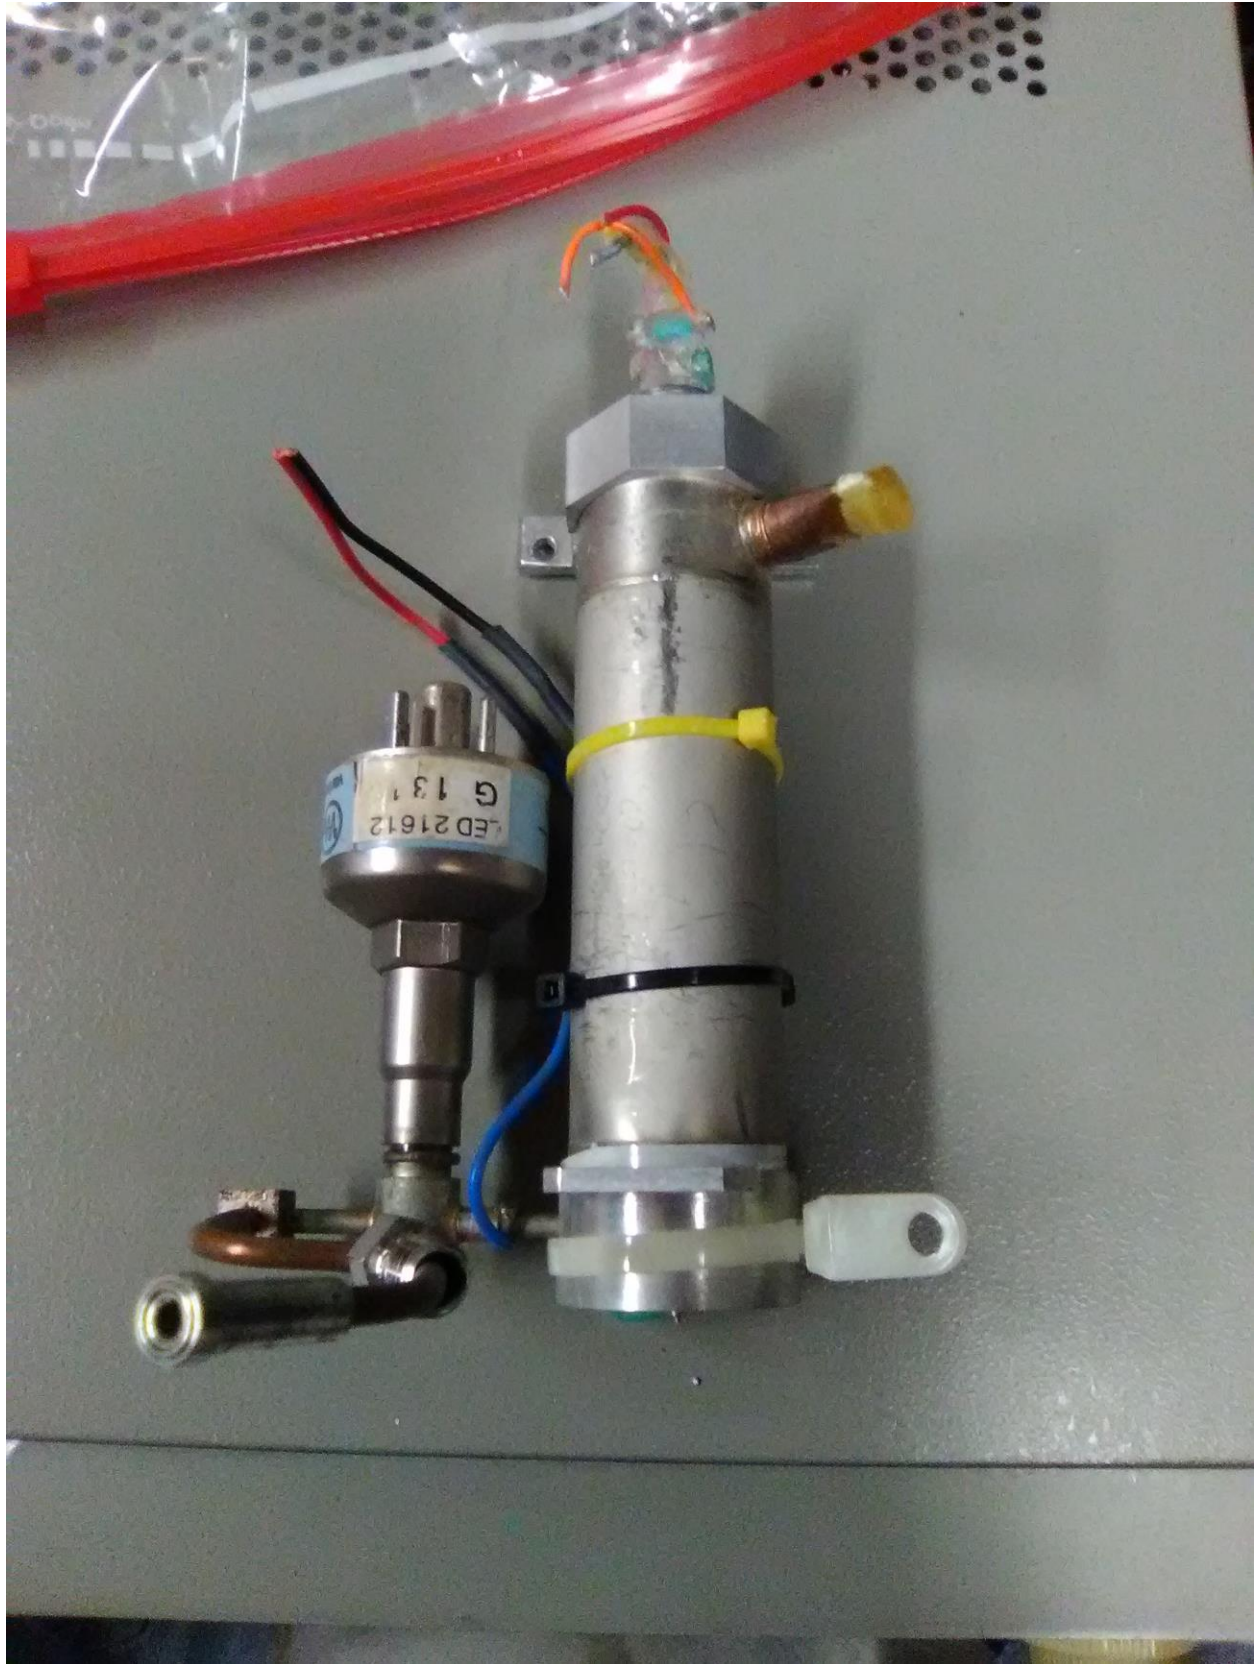
HYDRIDE CANISTER

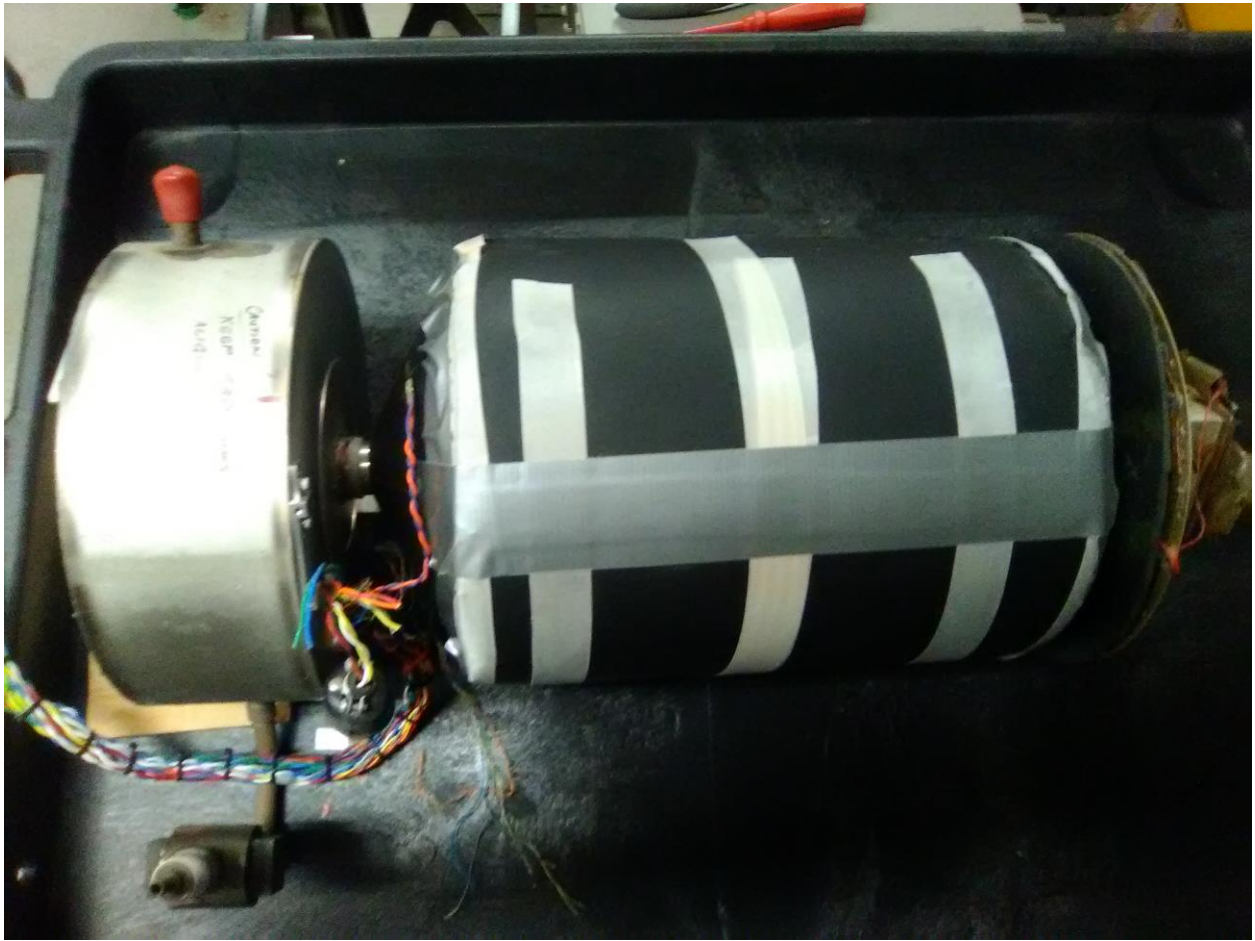
OUTER SHIELD REMOVED

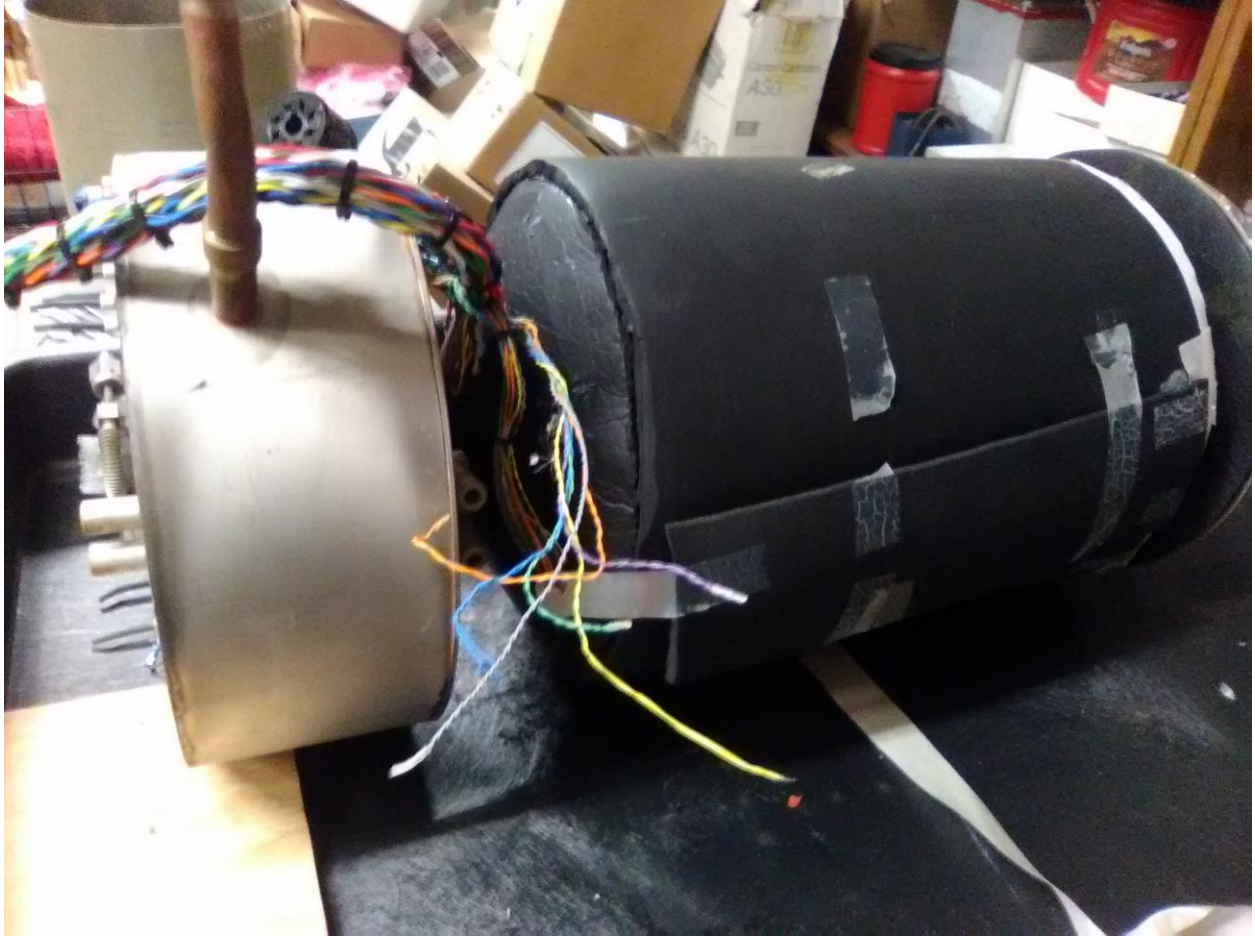
FIRST INSULATION LAYER

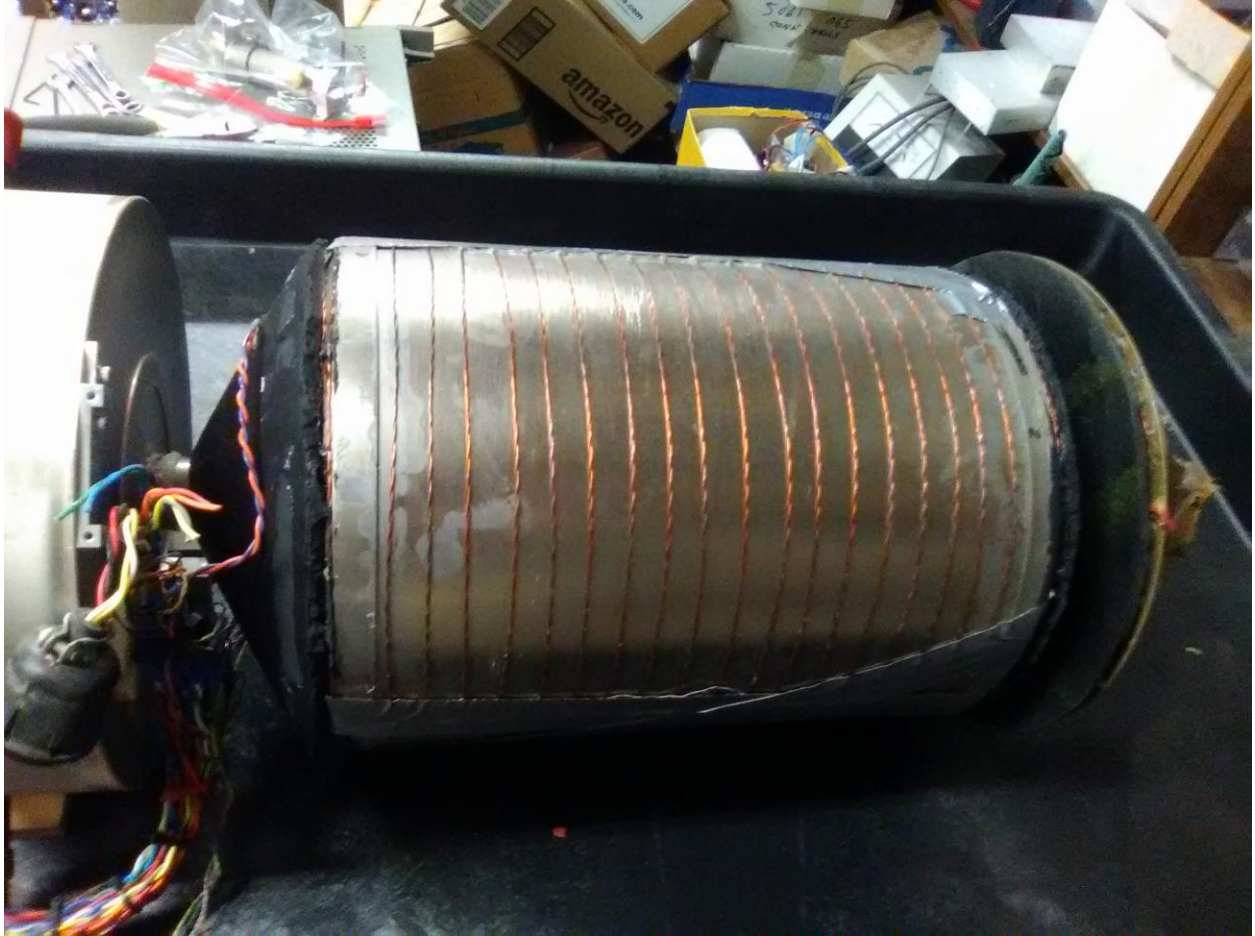
OUTER HEATER

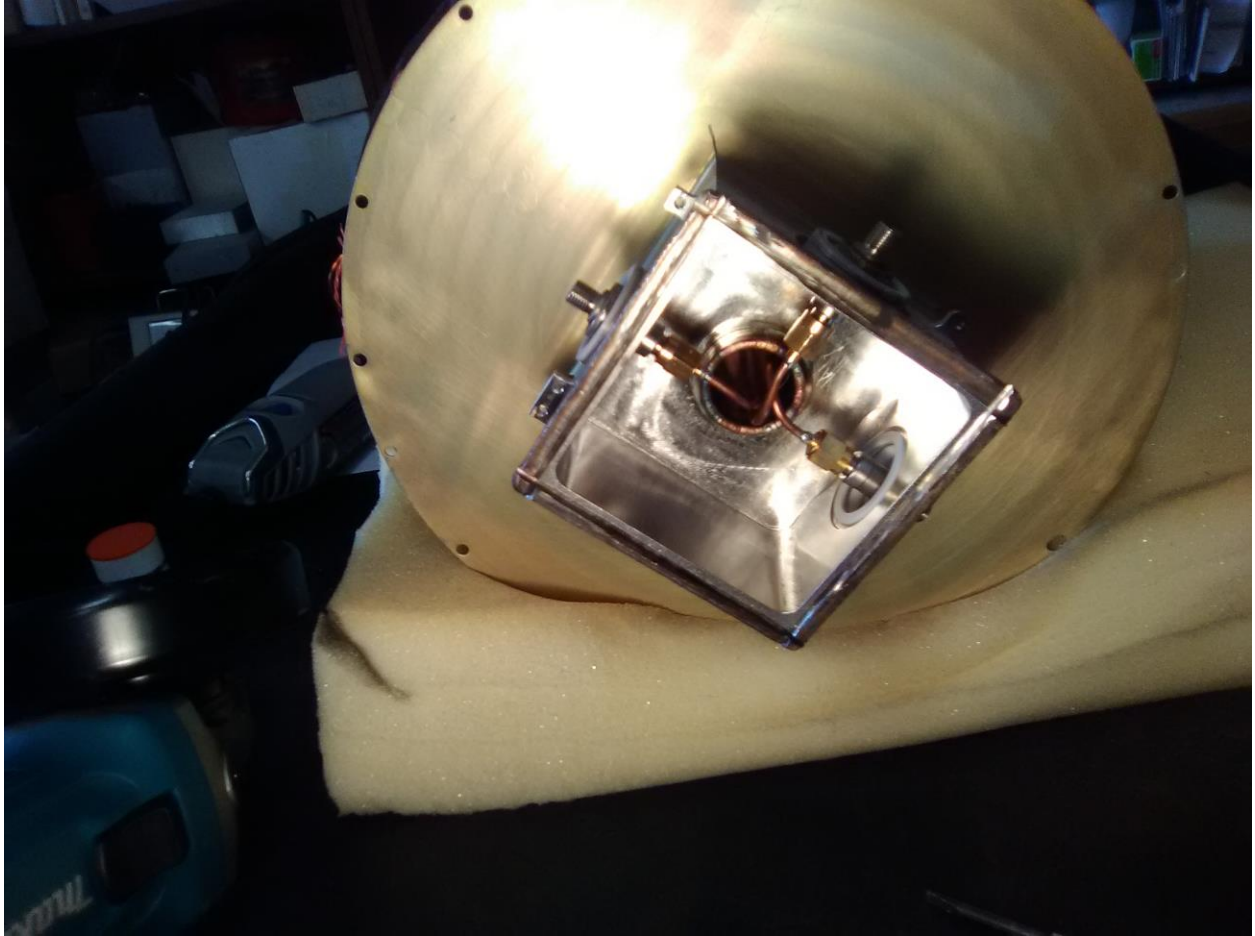
RF BOX

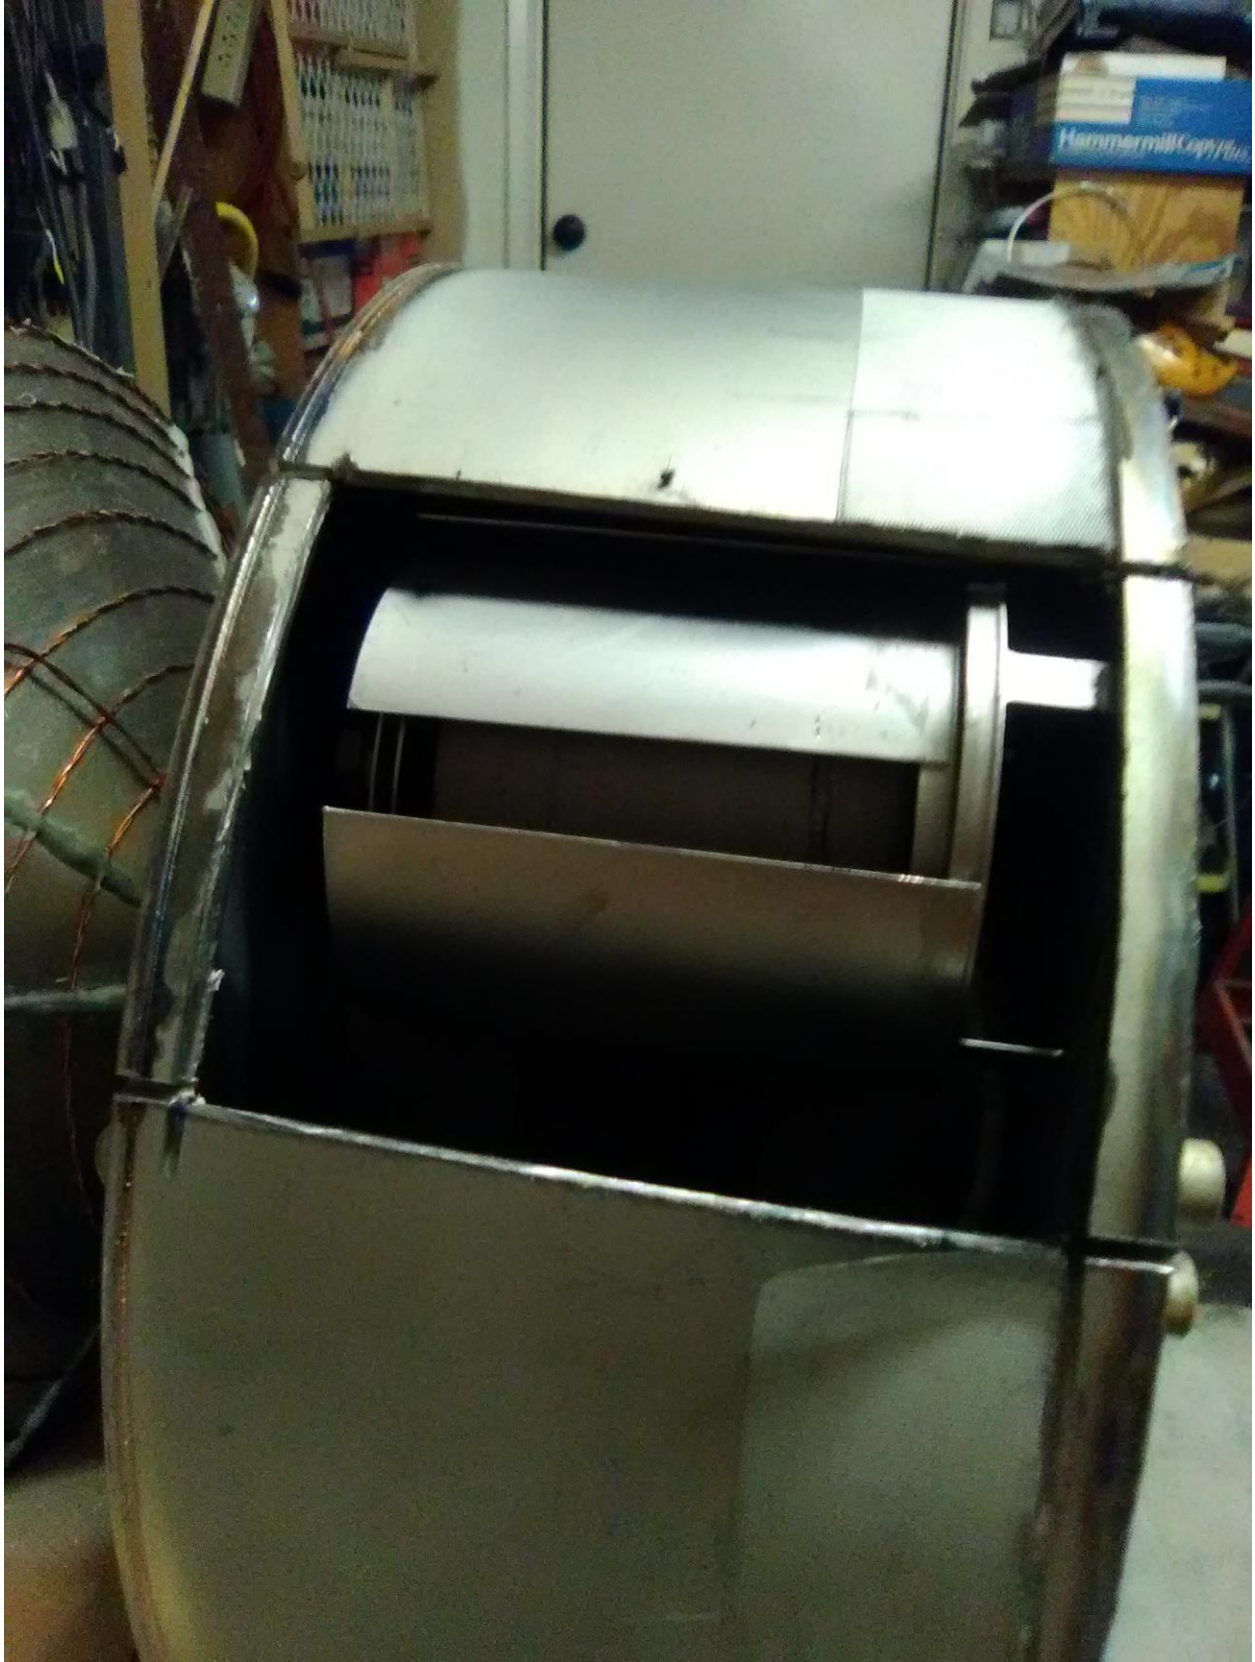
GETTER SLUG

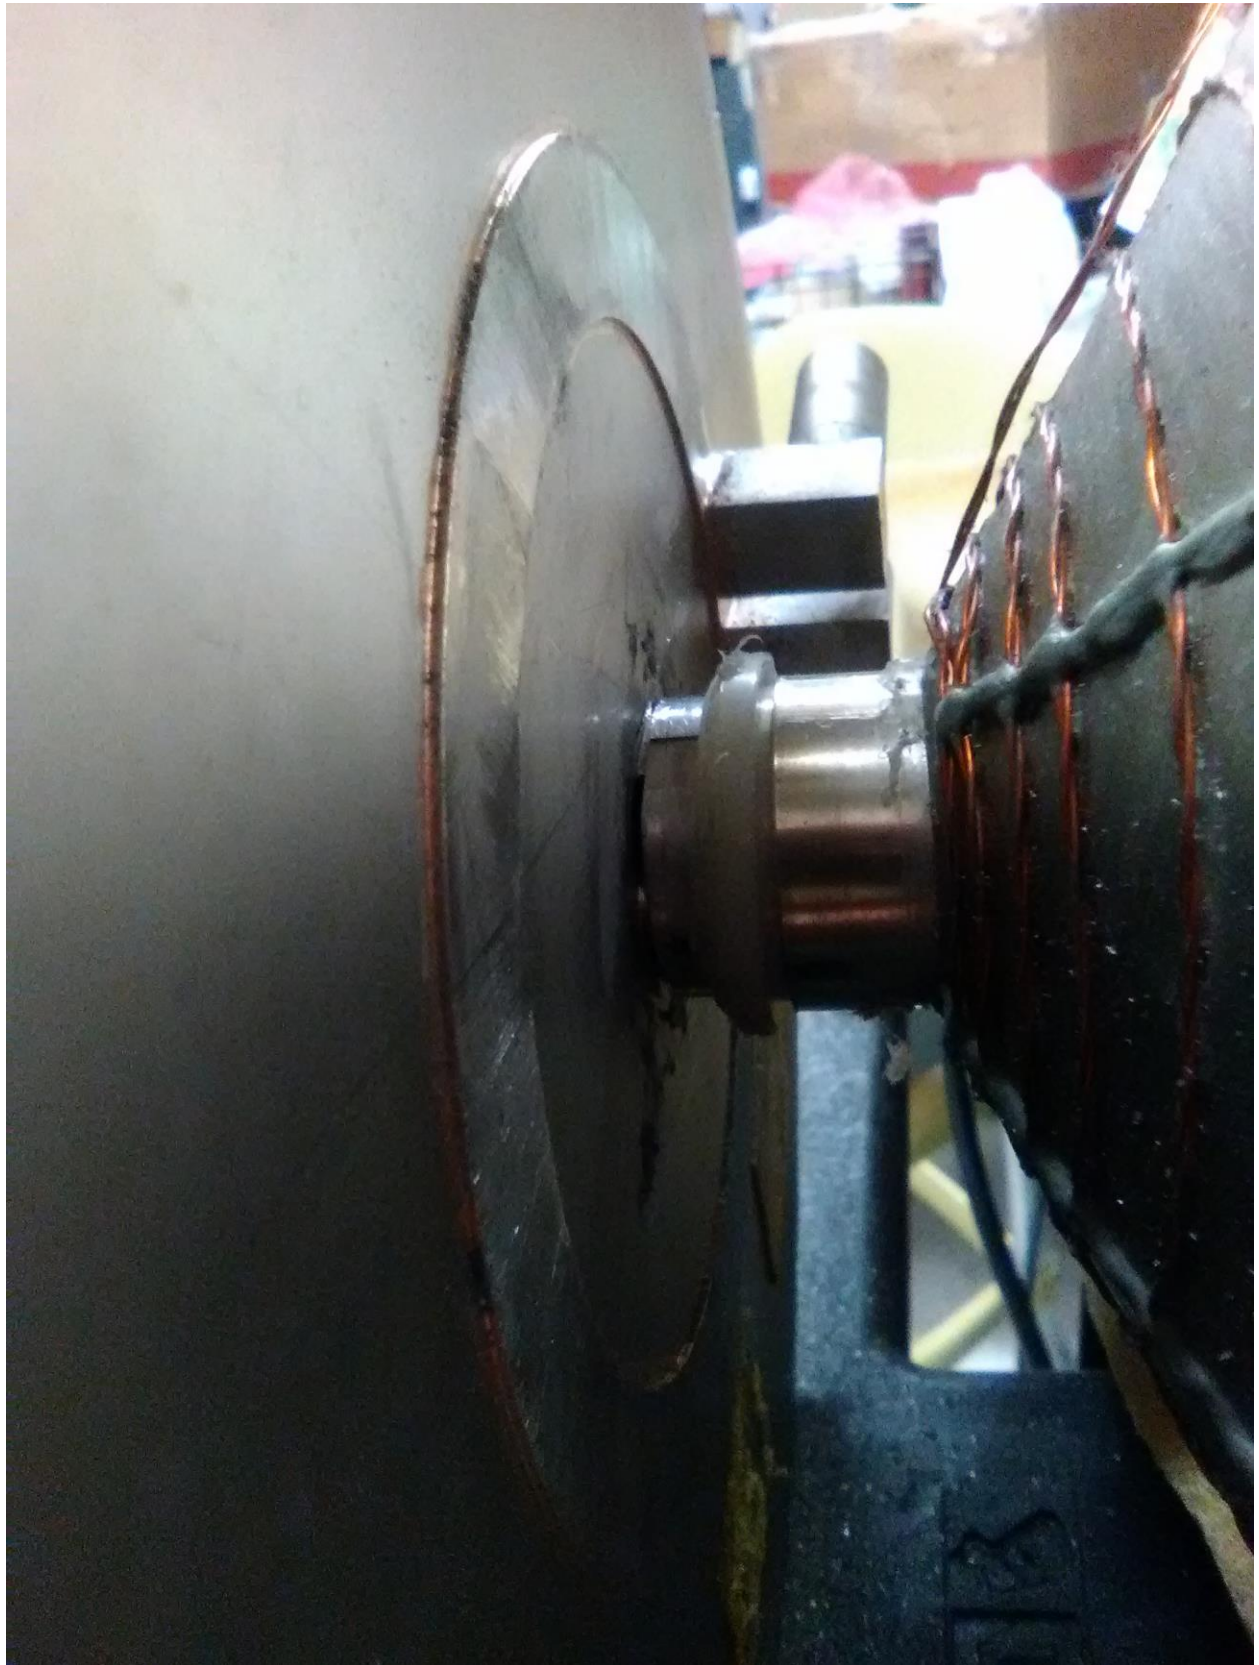
NECK COIL REMOVED

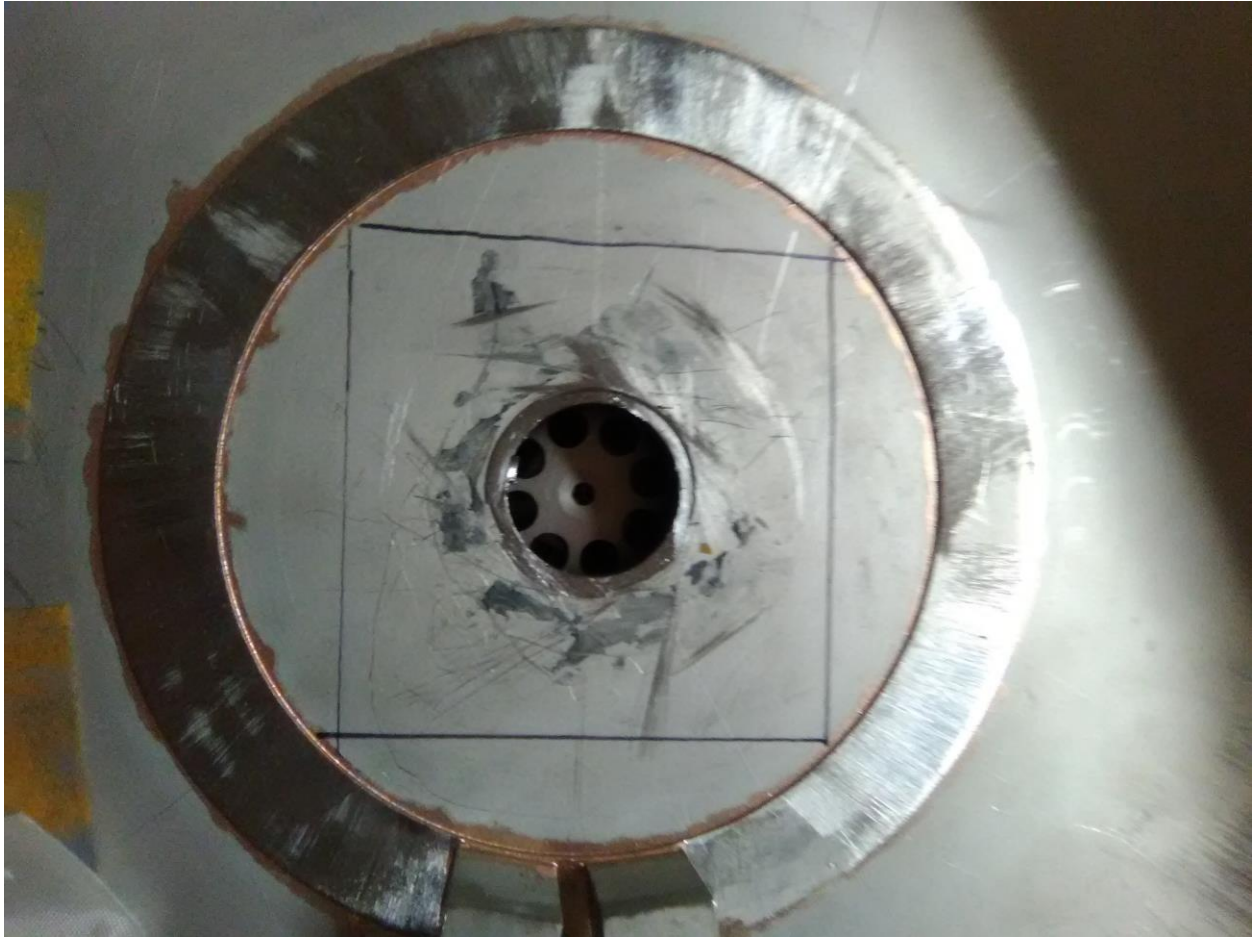
STATE SELECTOR MAGNET VISIBLE

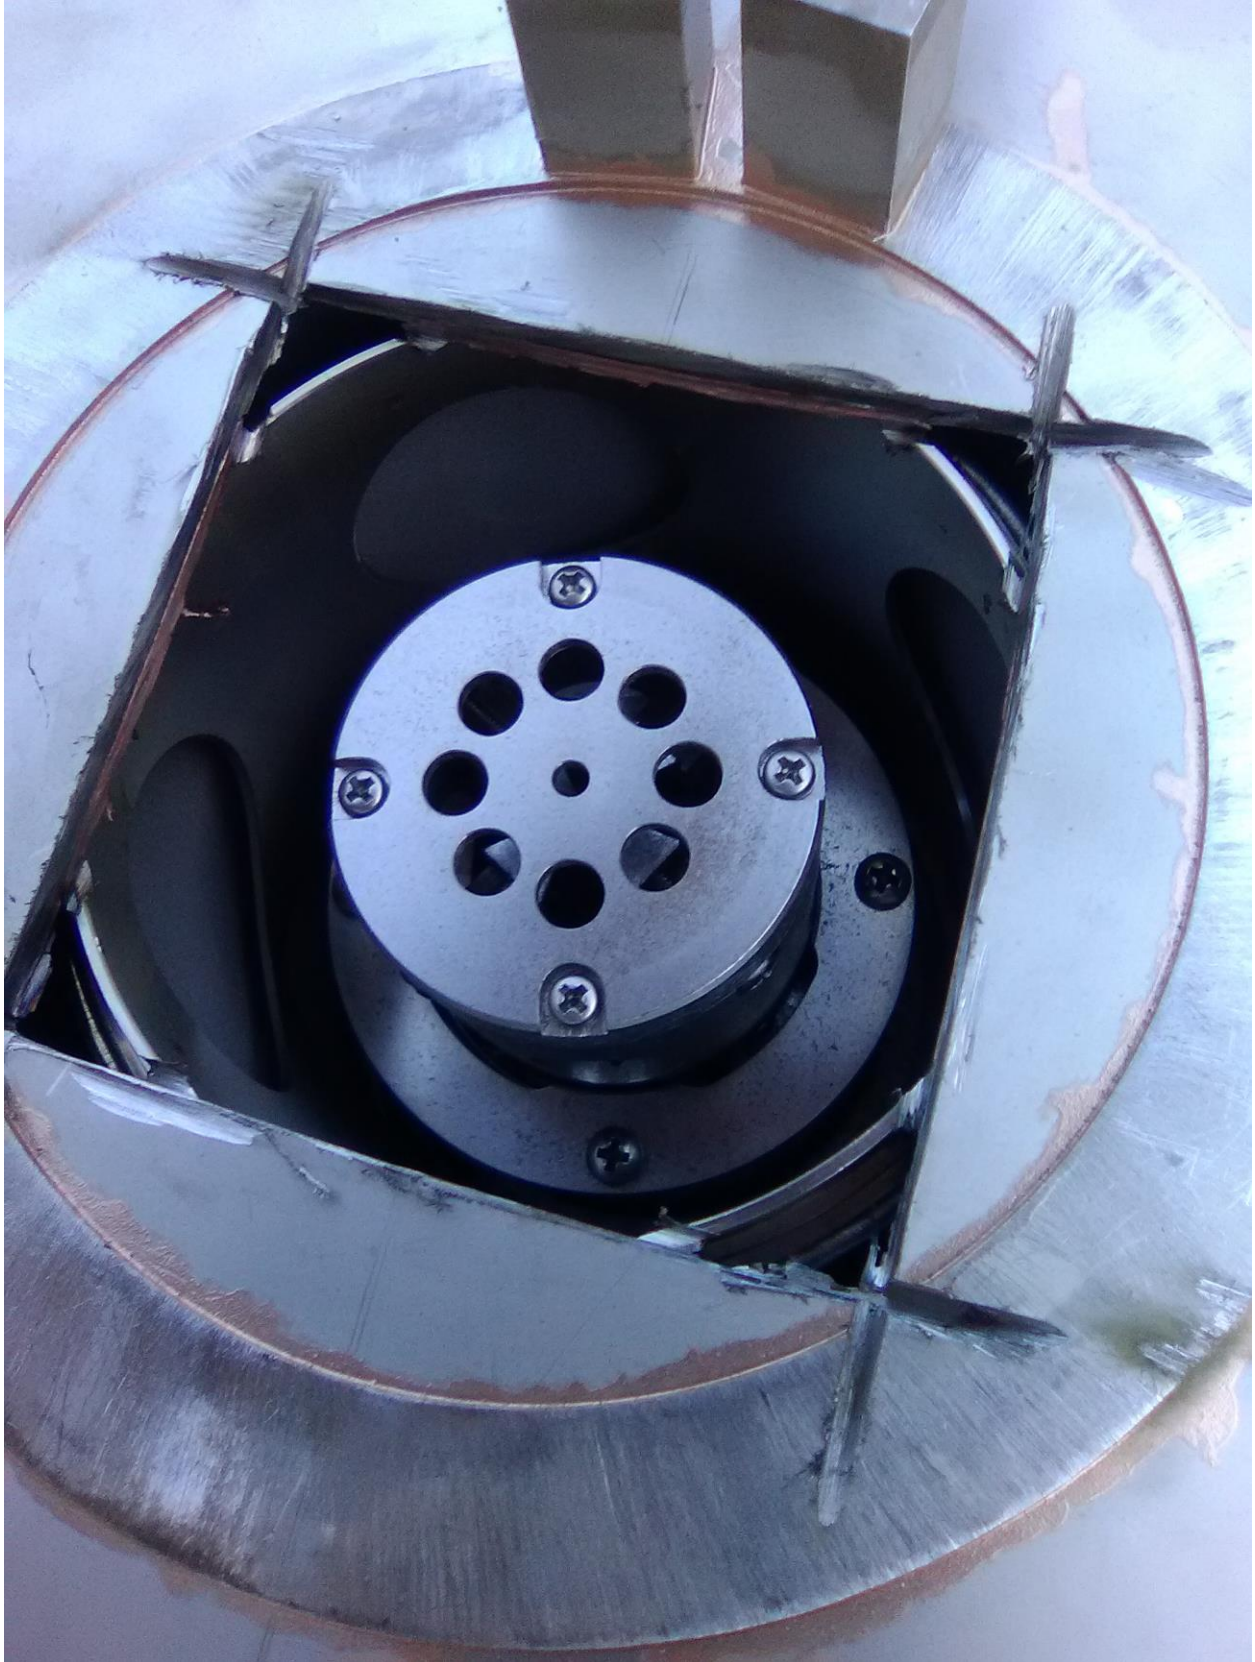
STATE SELECTOR MAGNET

This went well and after a bit more cutting the state selector magnet assembly was removed intact.

The hope at this point is that if a new varactor can be installed the state selector and a new dissociator bulb can be mounted.

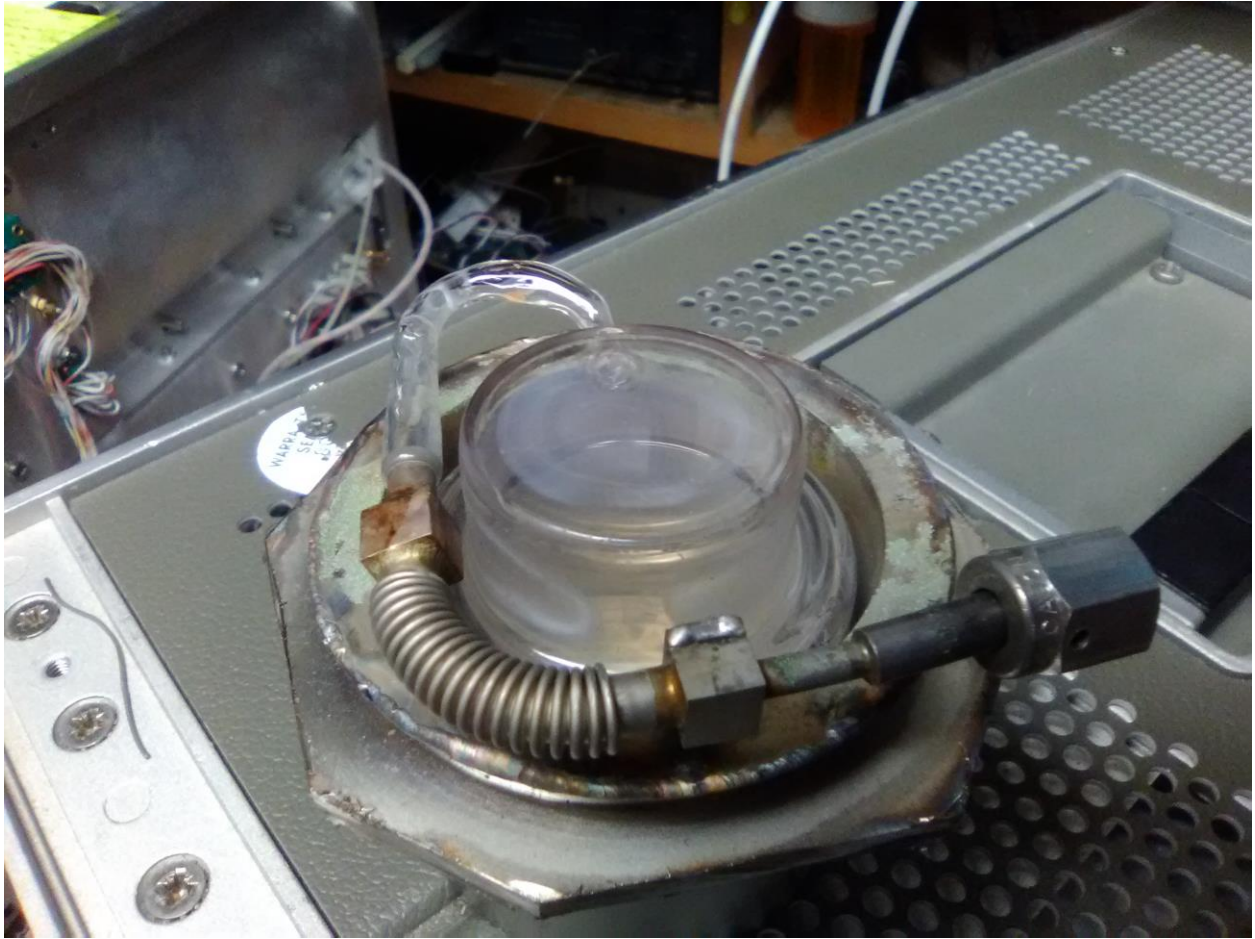
DISSOCIATOR

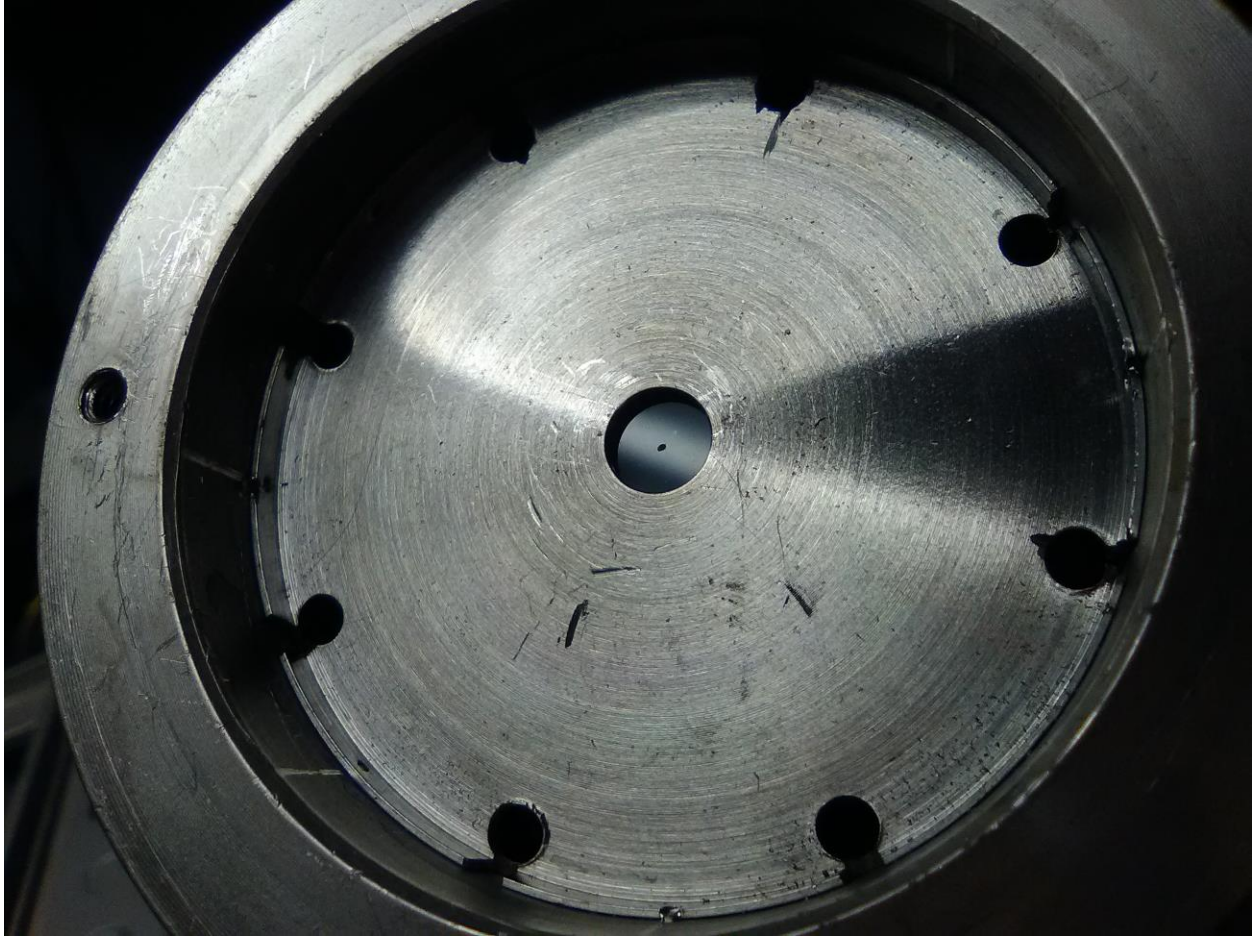
DISSOCIATOR ORIFICE

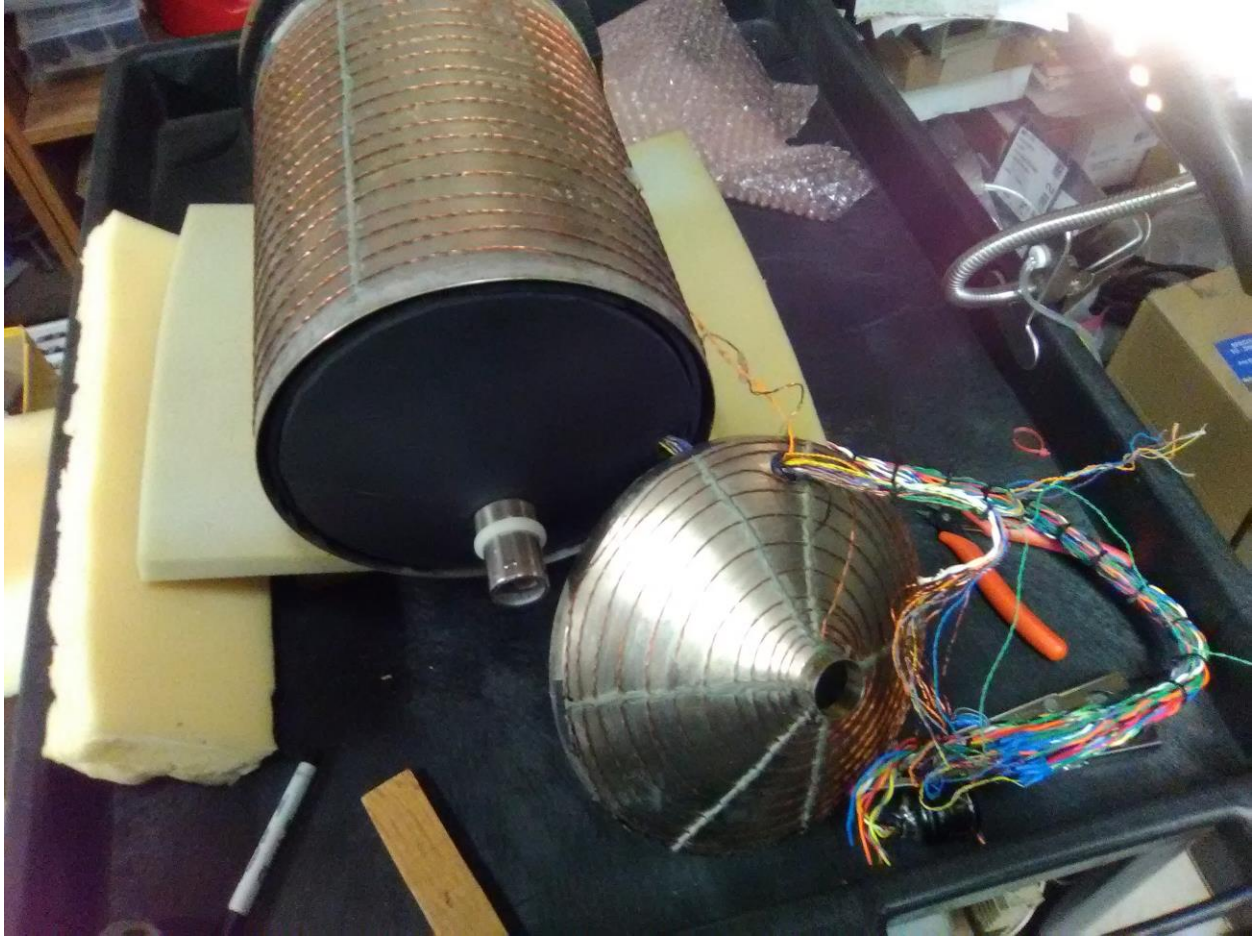
OUTER HEATER AND END CAP
