UPDATE FIVE

Well here is the next installment of the continuing saga of trying to resurrect a Passive Maser.

This Maser was one built under a Hughes Aircraft Company project the "Earthbased Compact Hydrogen Maser" circa 1985.

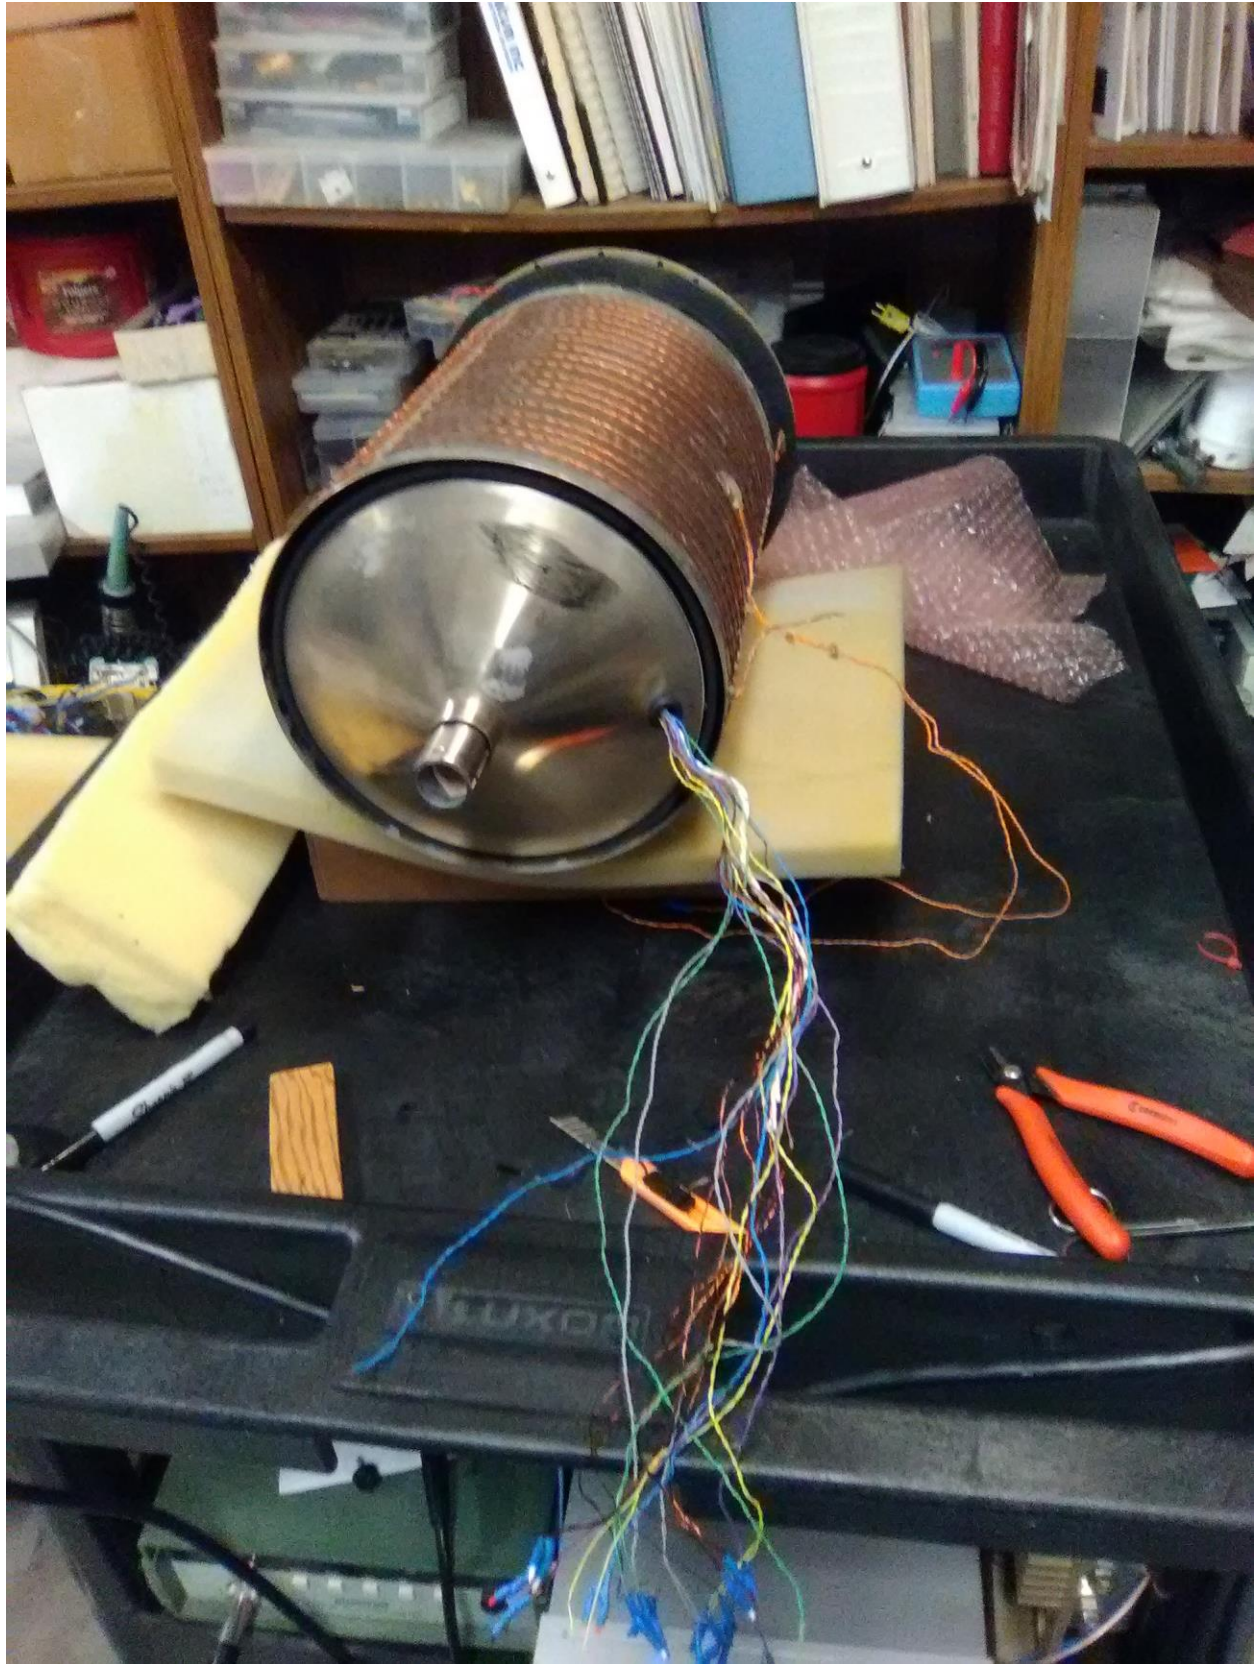
OUTER HEATER AND END CAP

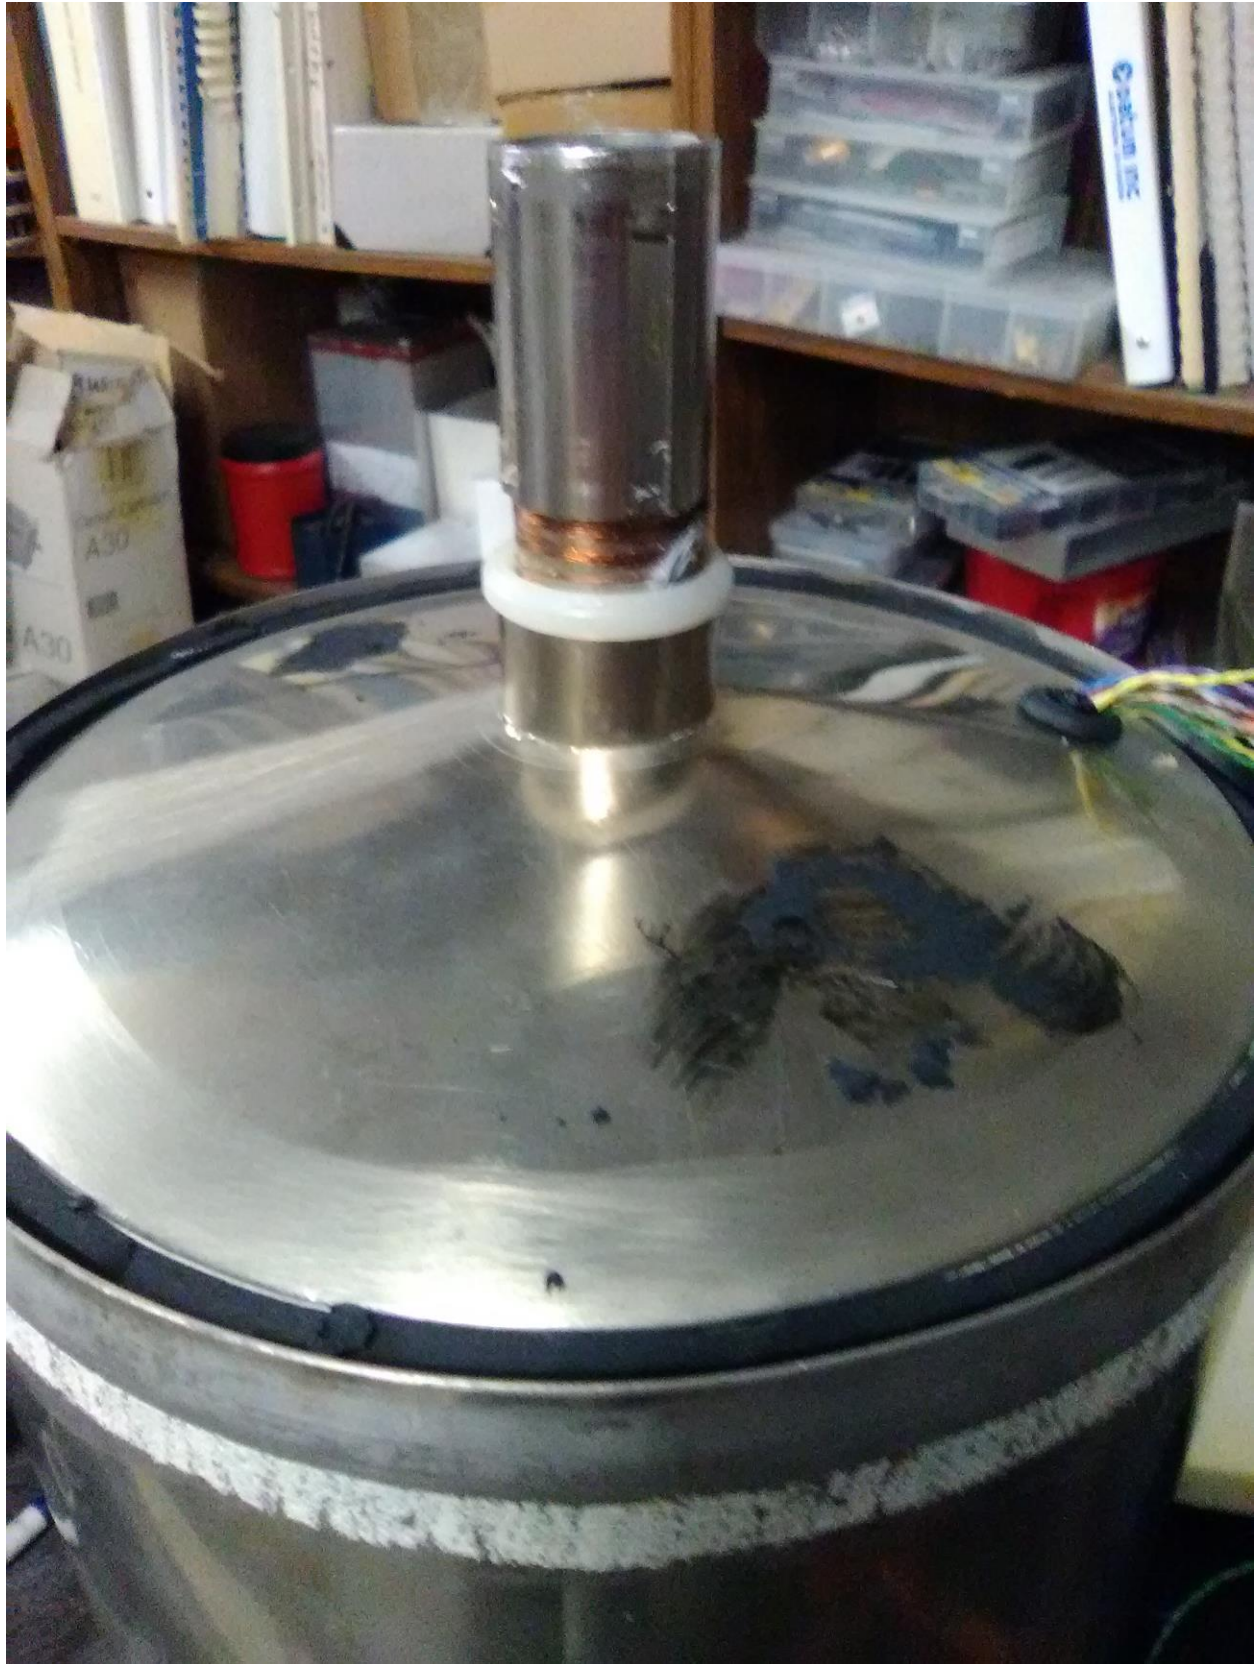
END HEATER

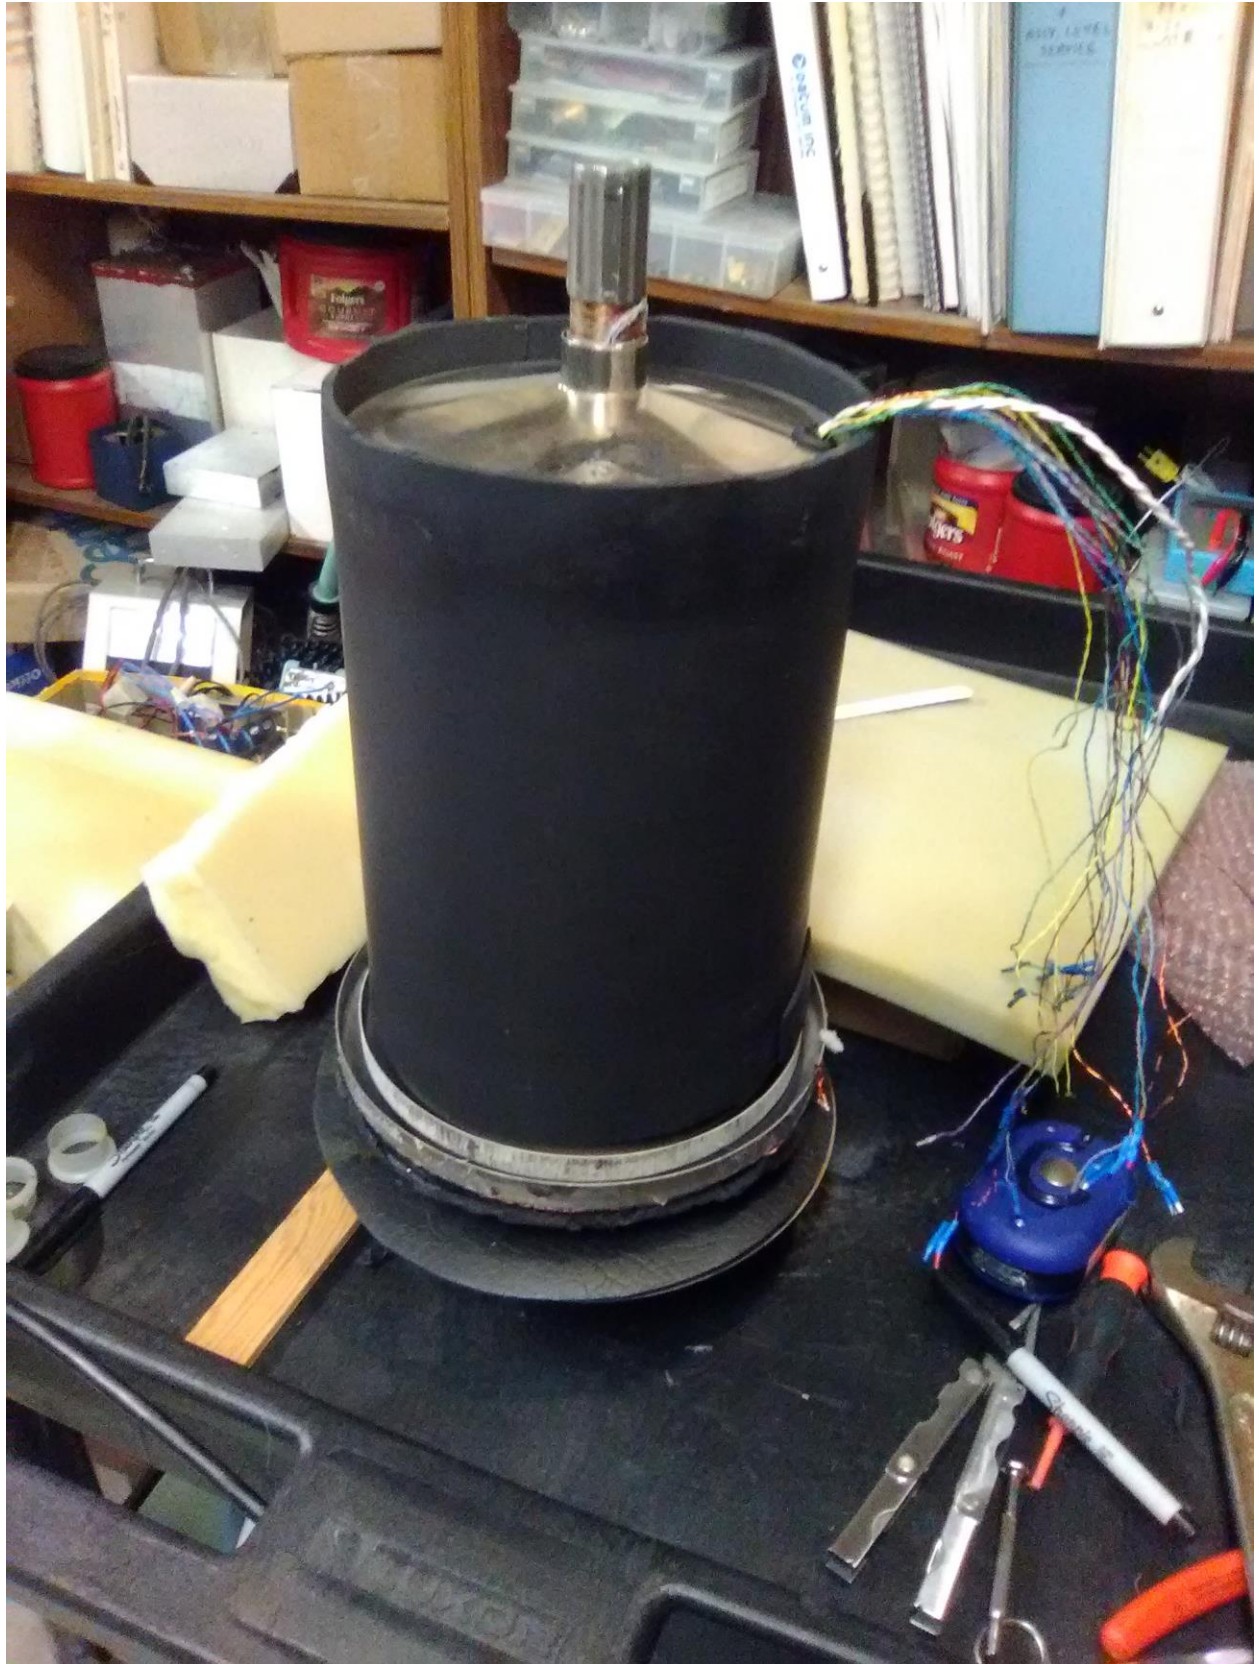
NEXT LAYER

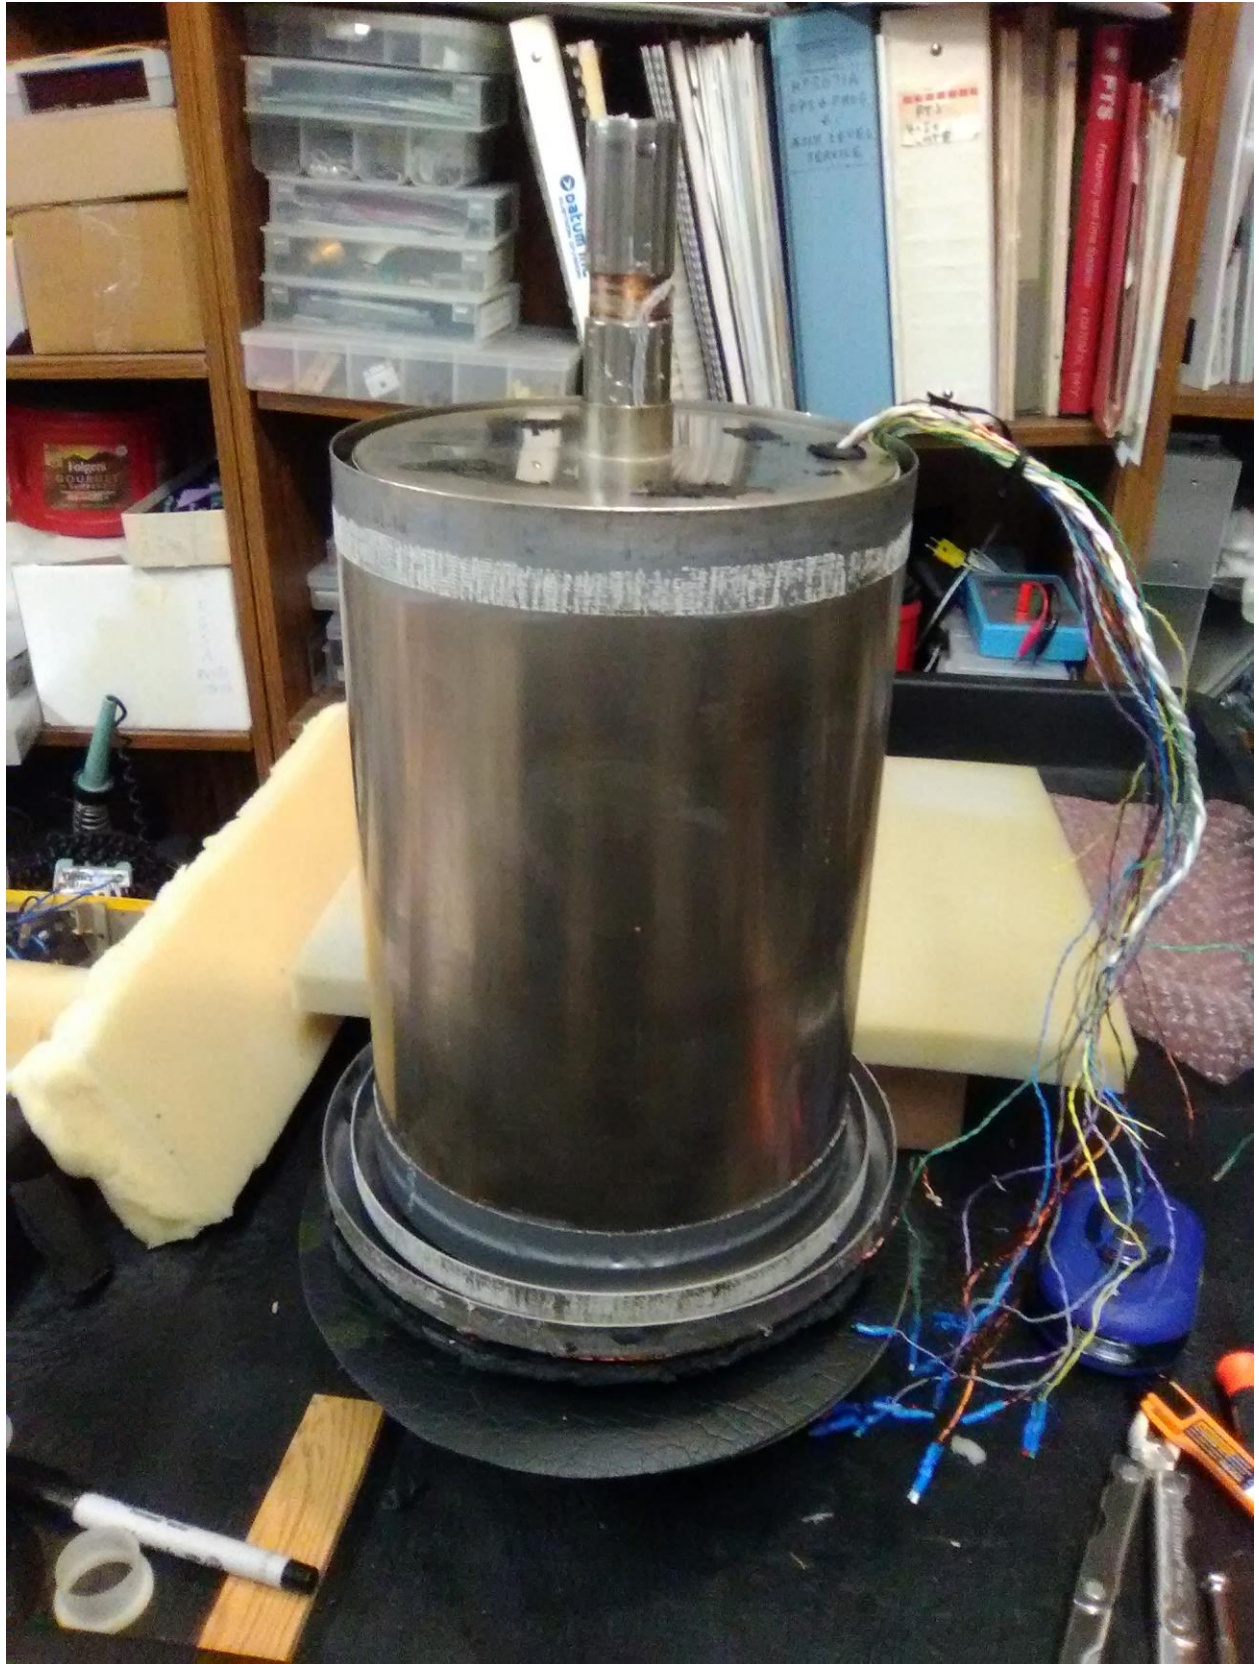
FINAL END CAP

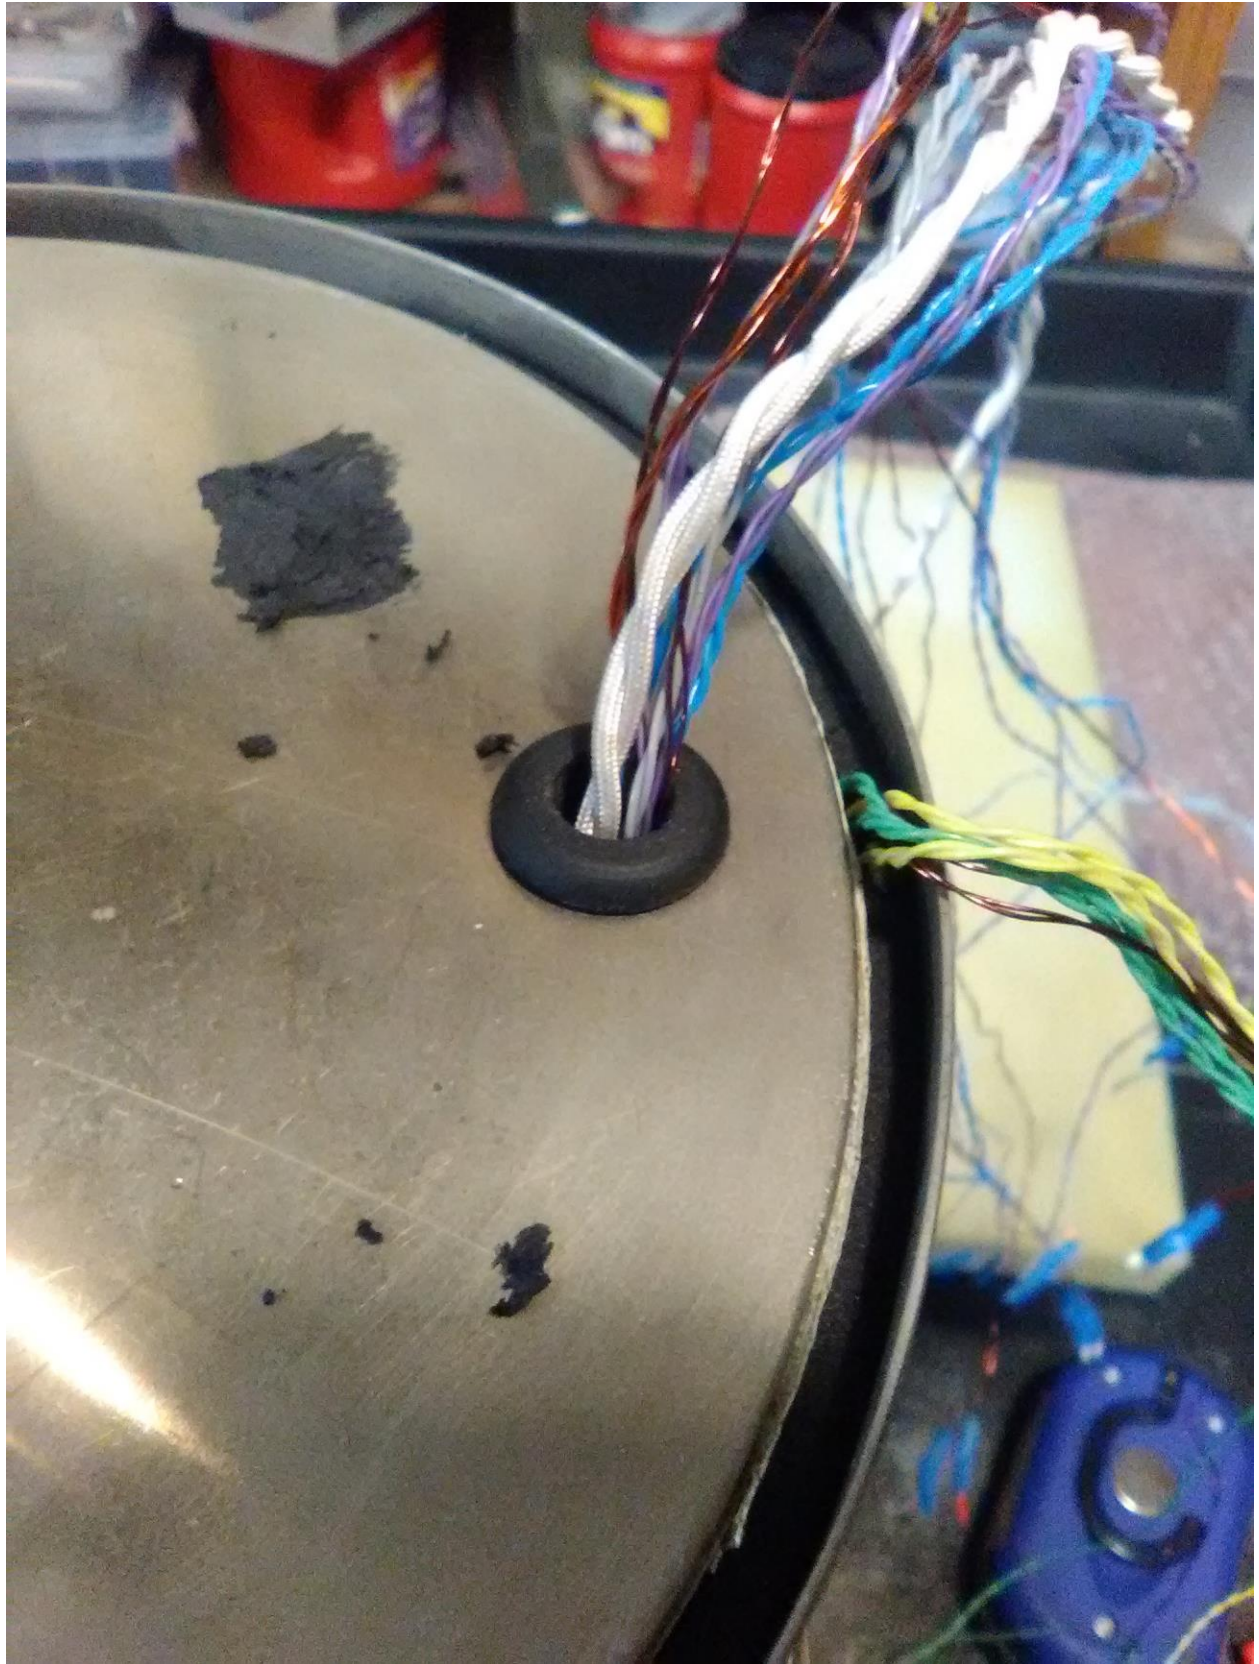
WIRING DETAILS

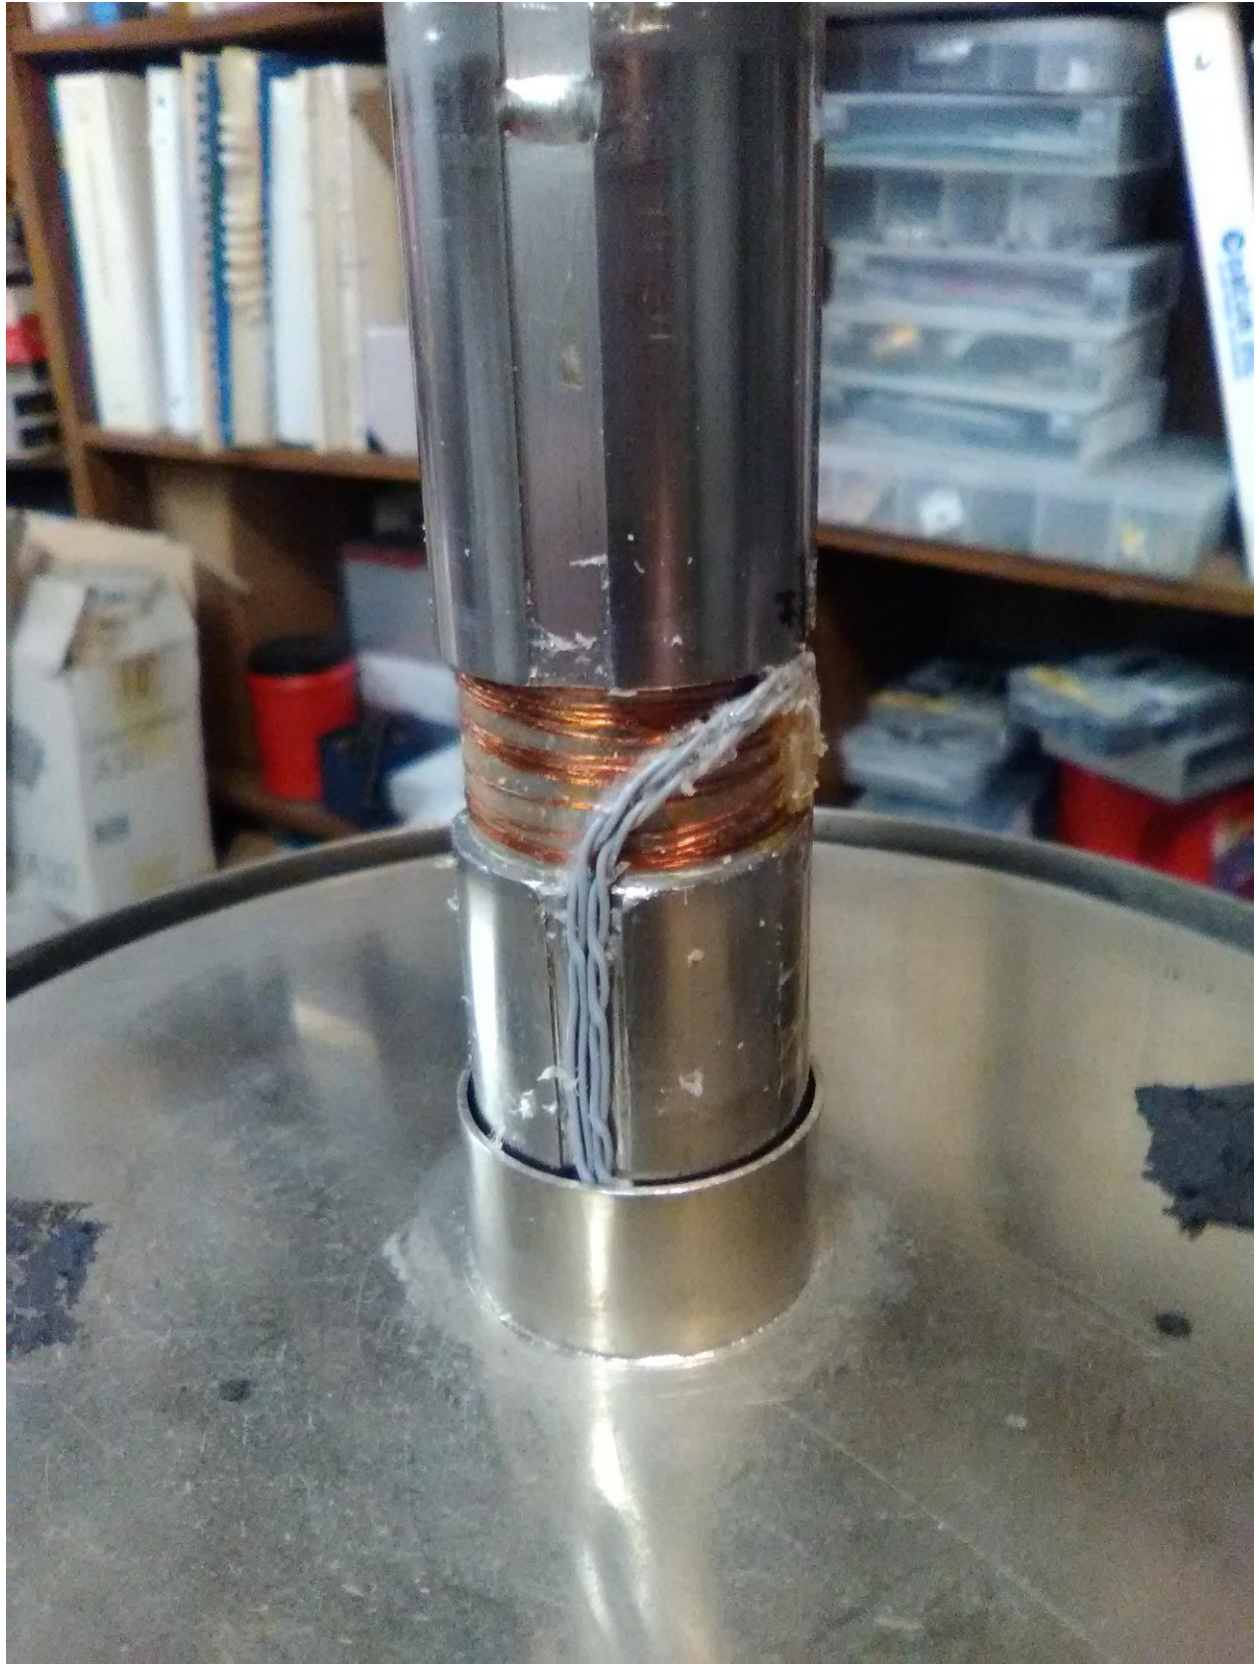
FINAL END CAP AND END HEATER

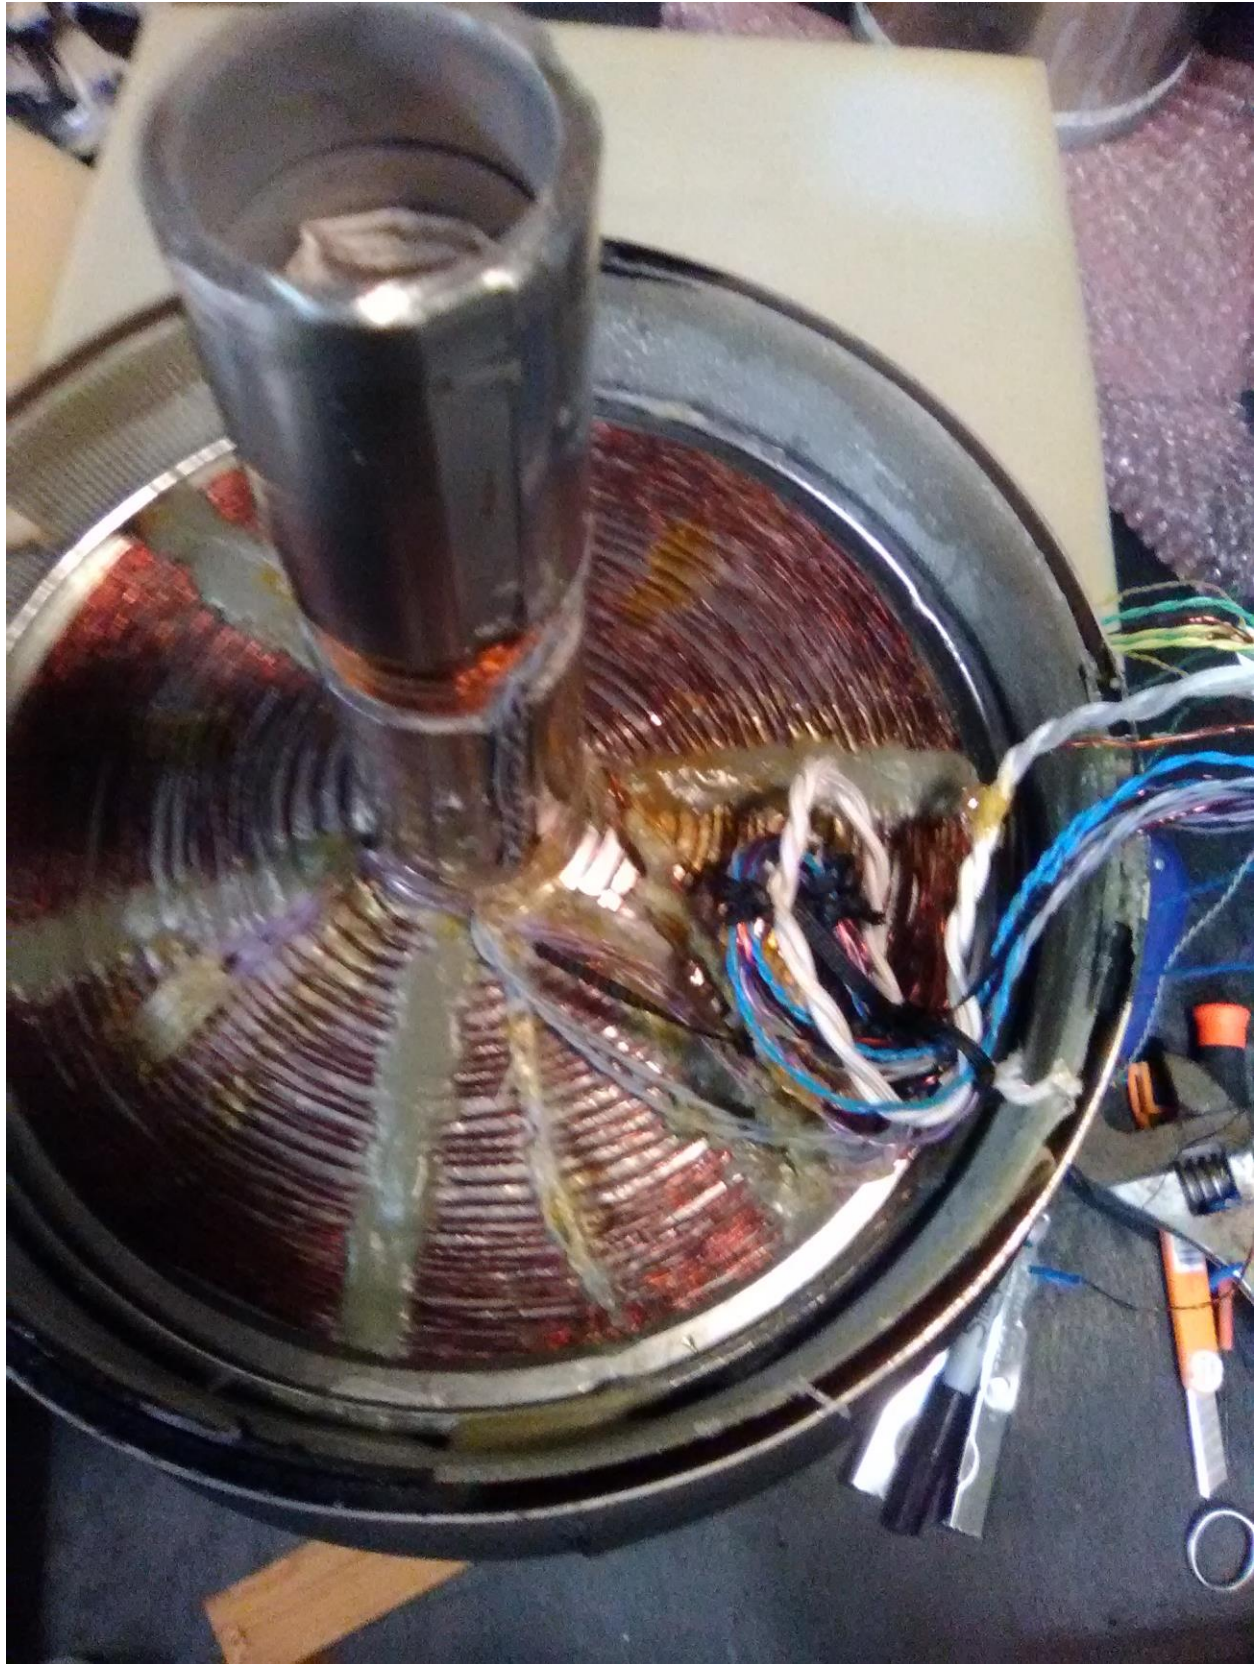
VACUUM ENVELOPE END HEATER

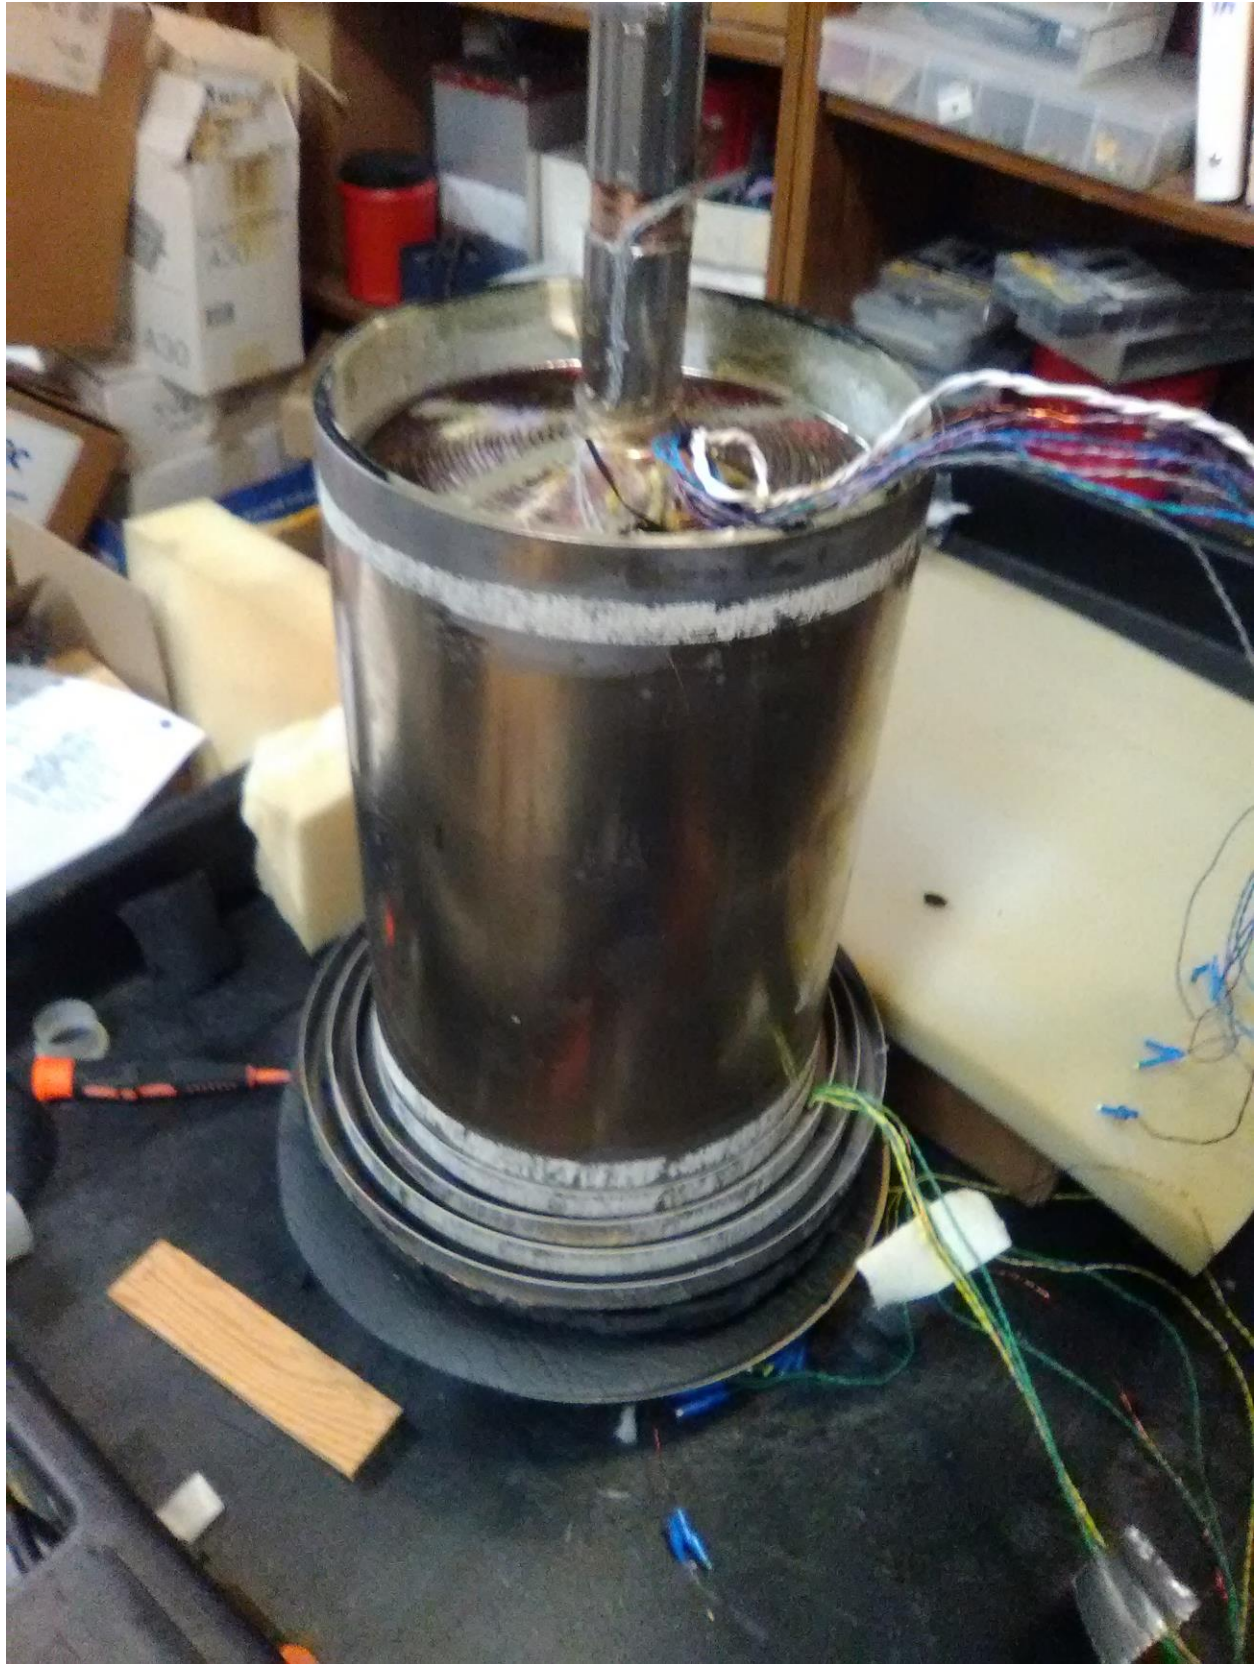
VACUUM ENVELOPE END HEATER AND LAST SHIELD

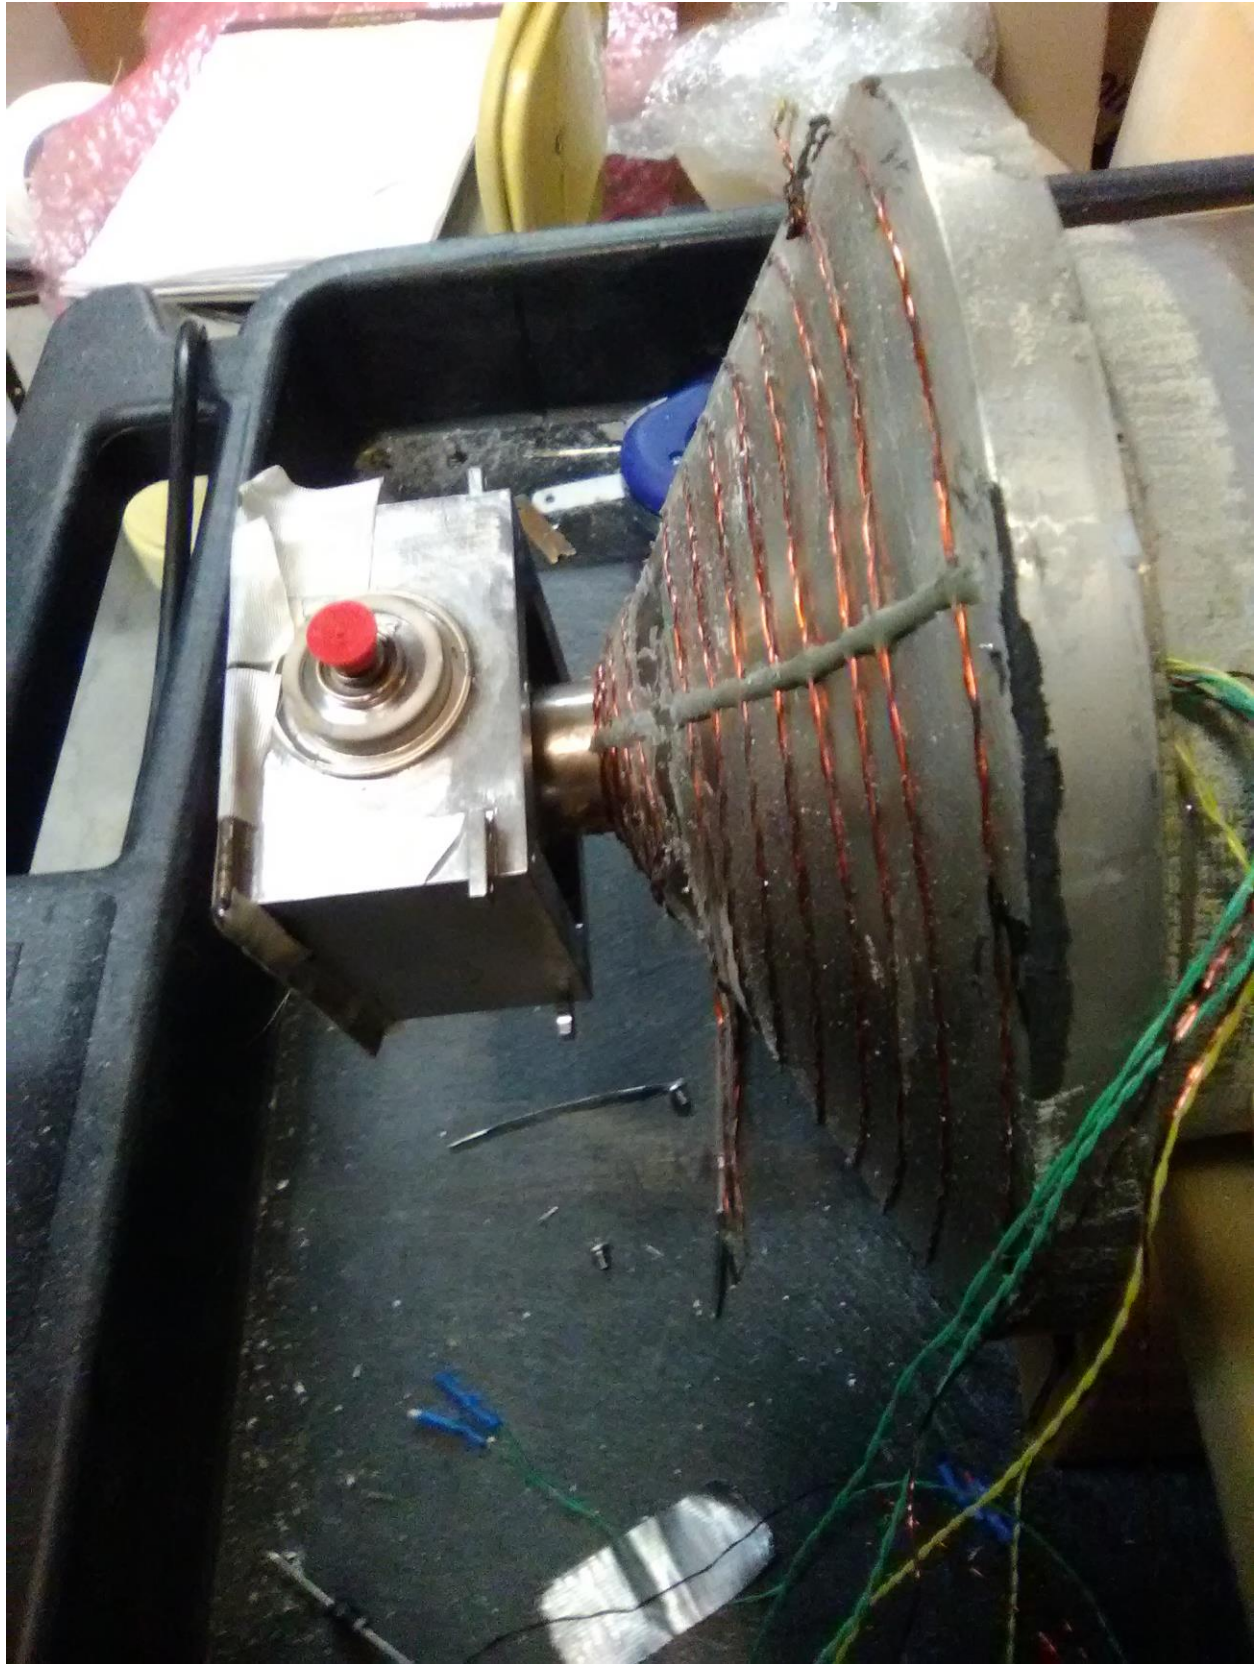
RF BOX END PRIOR TO CUT

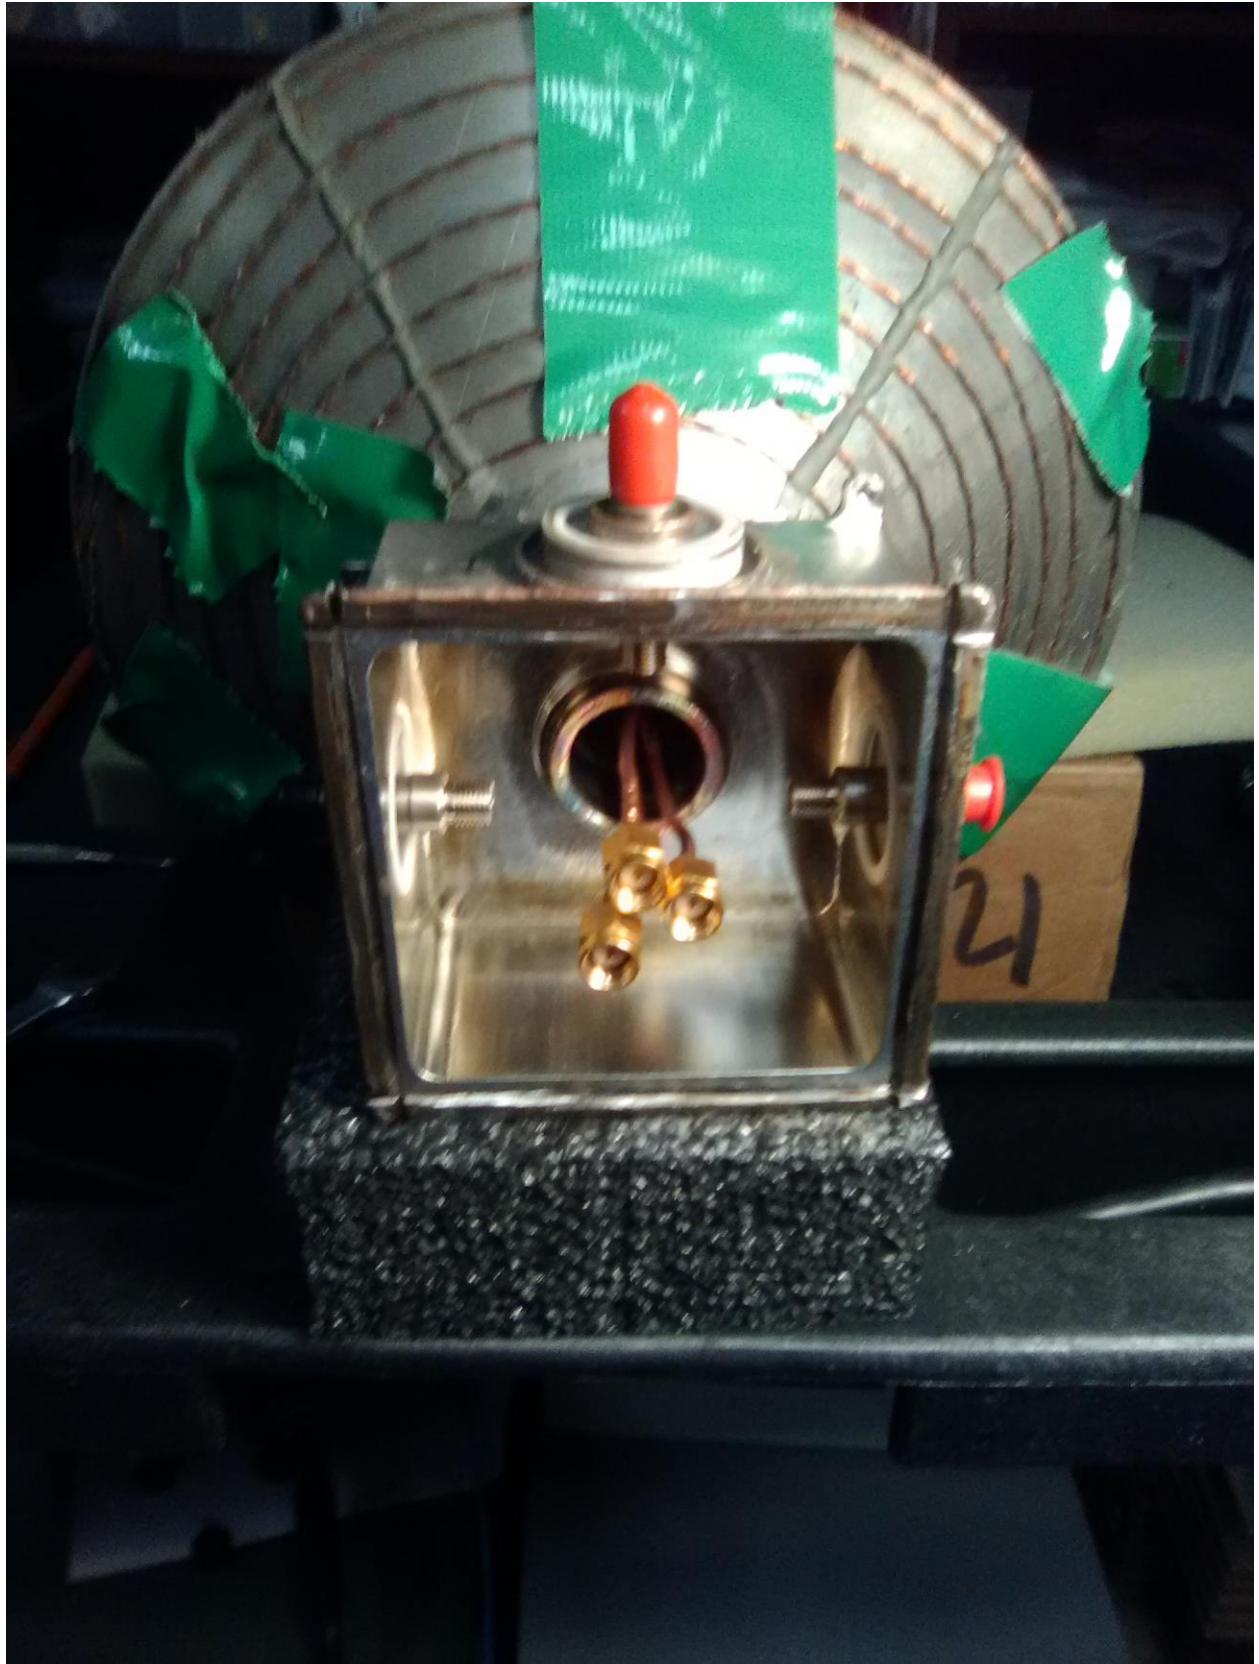
RF BOX SMA DISCONNECTED

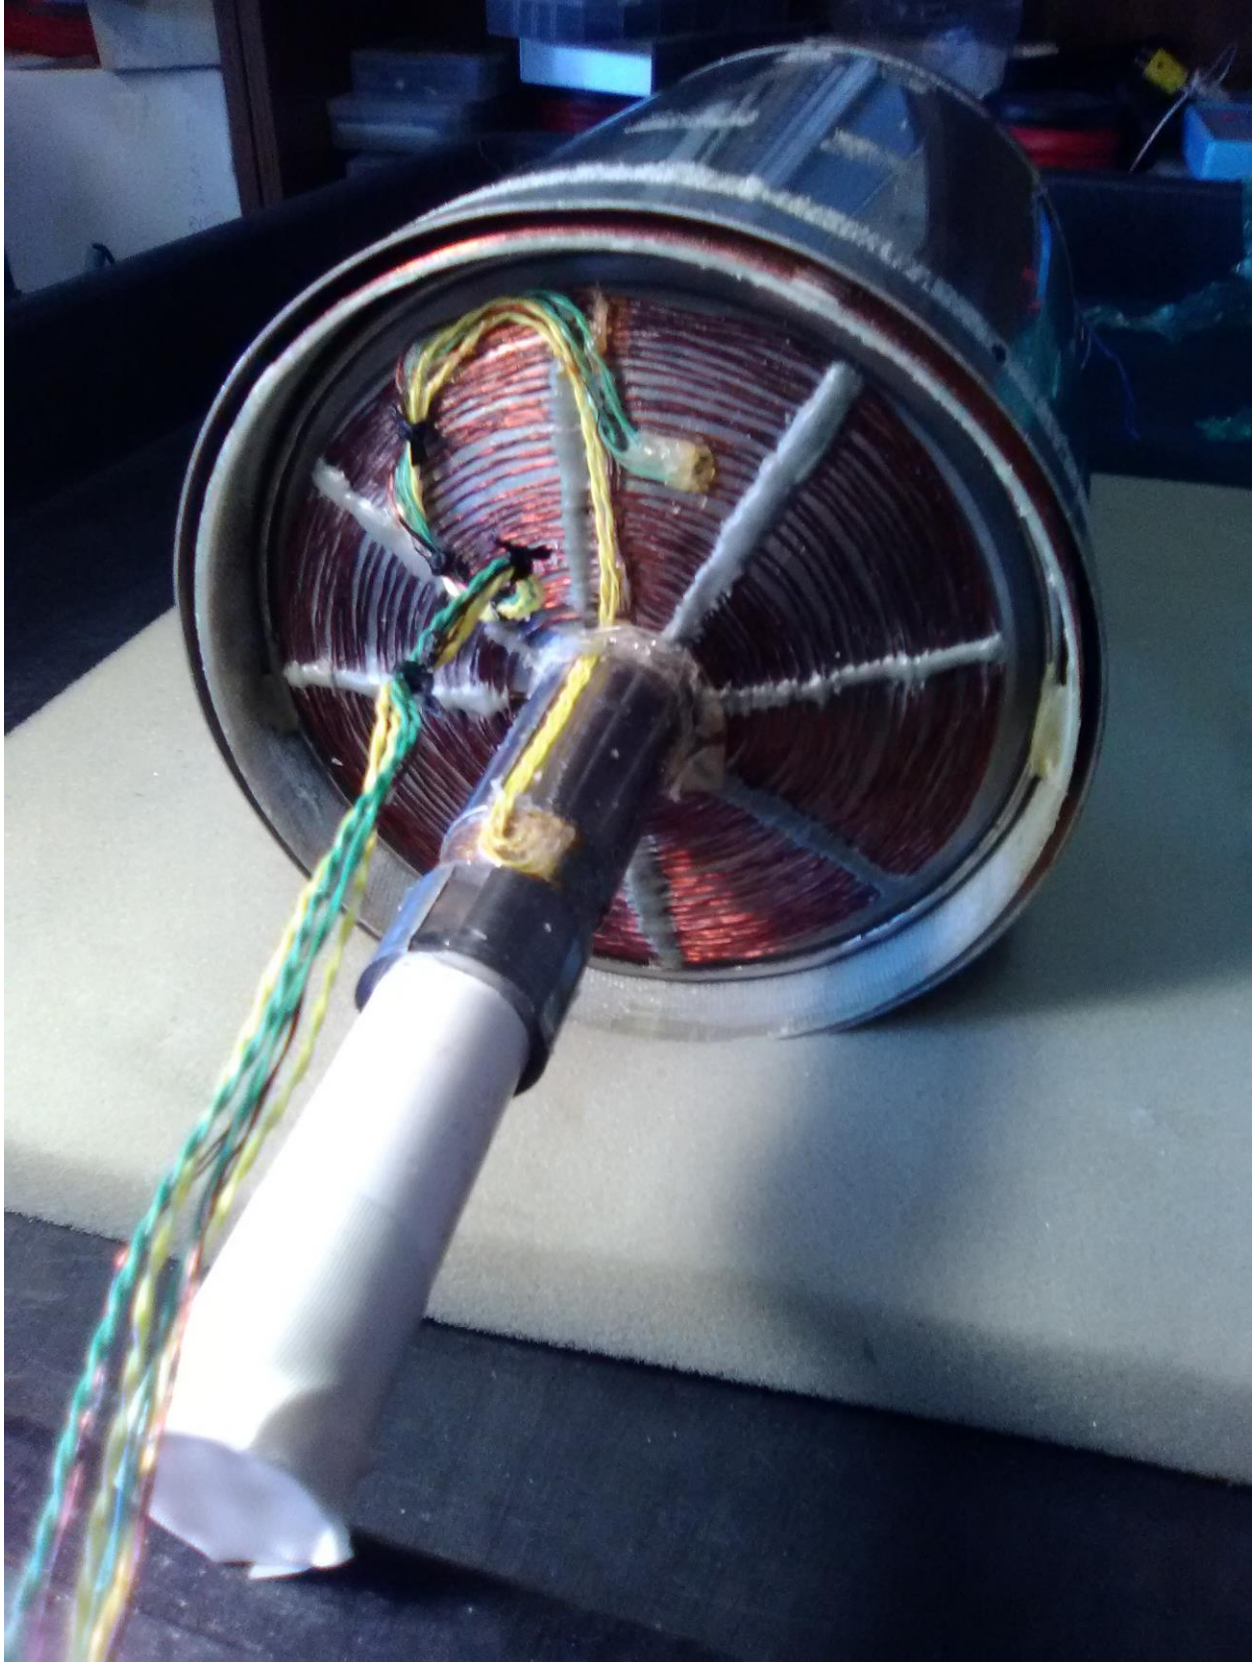
VACUUM ENVELOPE END HEATER. SMA CABLES SHIELDED PRIOR TO CUT
