UPDATE FIVE

Well here is the next installment of the continuing saga of trying to resurrect a Passive Maser.

This Maser was one built under a Hughes Aircraft Company project the "Earthbased Compact Hydrogen Maser" circa 1985.

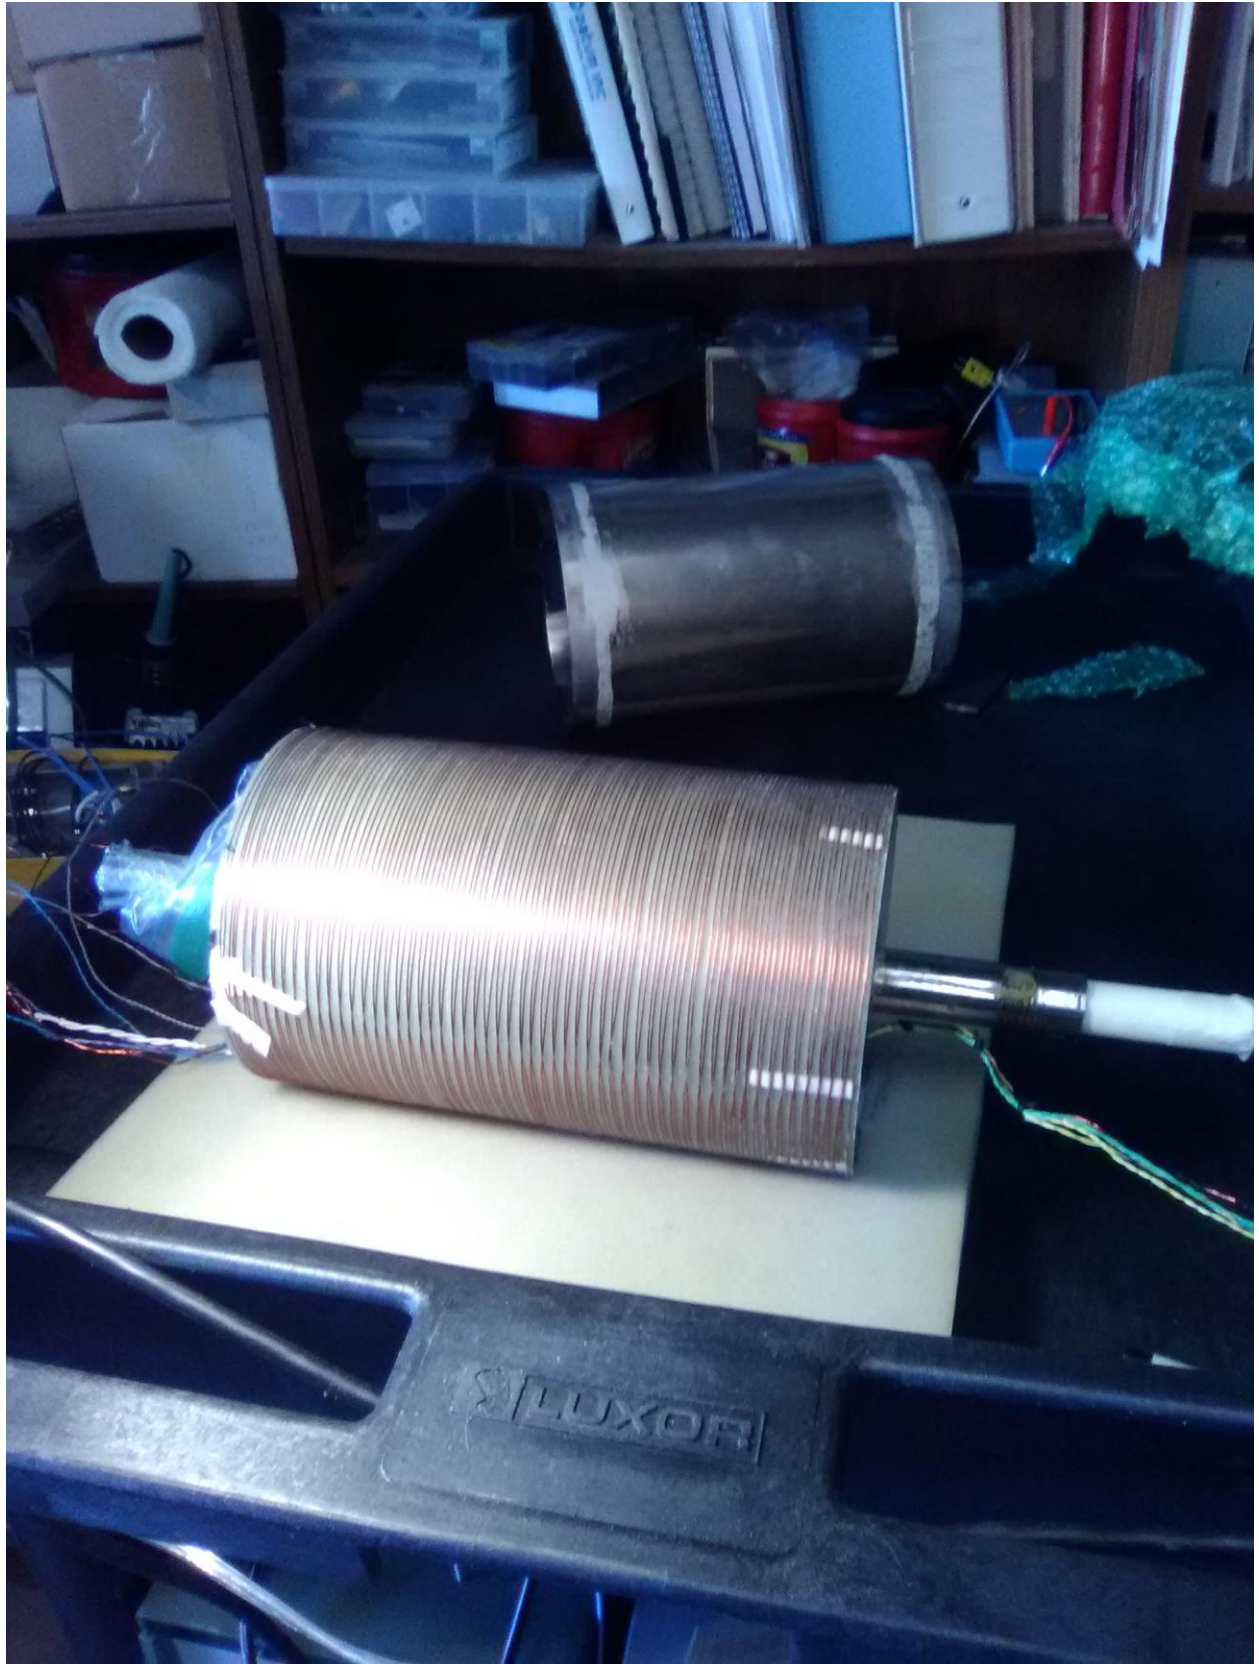
RF BOX REMOVED. LAST SHIELD REMOVED. C-FIELD WINDING EXPOSED

After cutting off the SMA mounting "box" I was able to remove the magnetic shield end caps and cylinders.

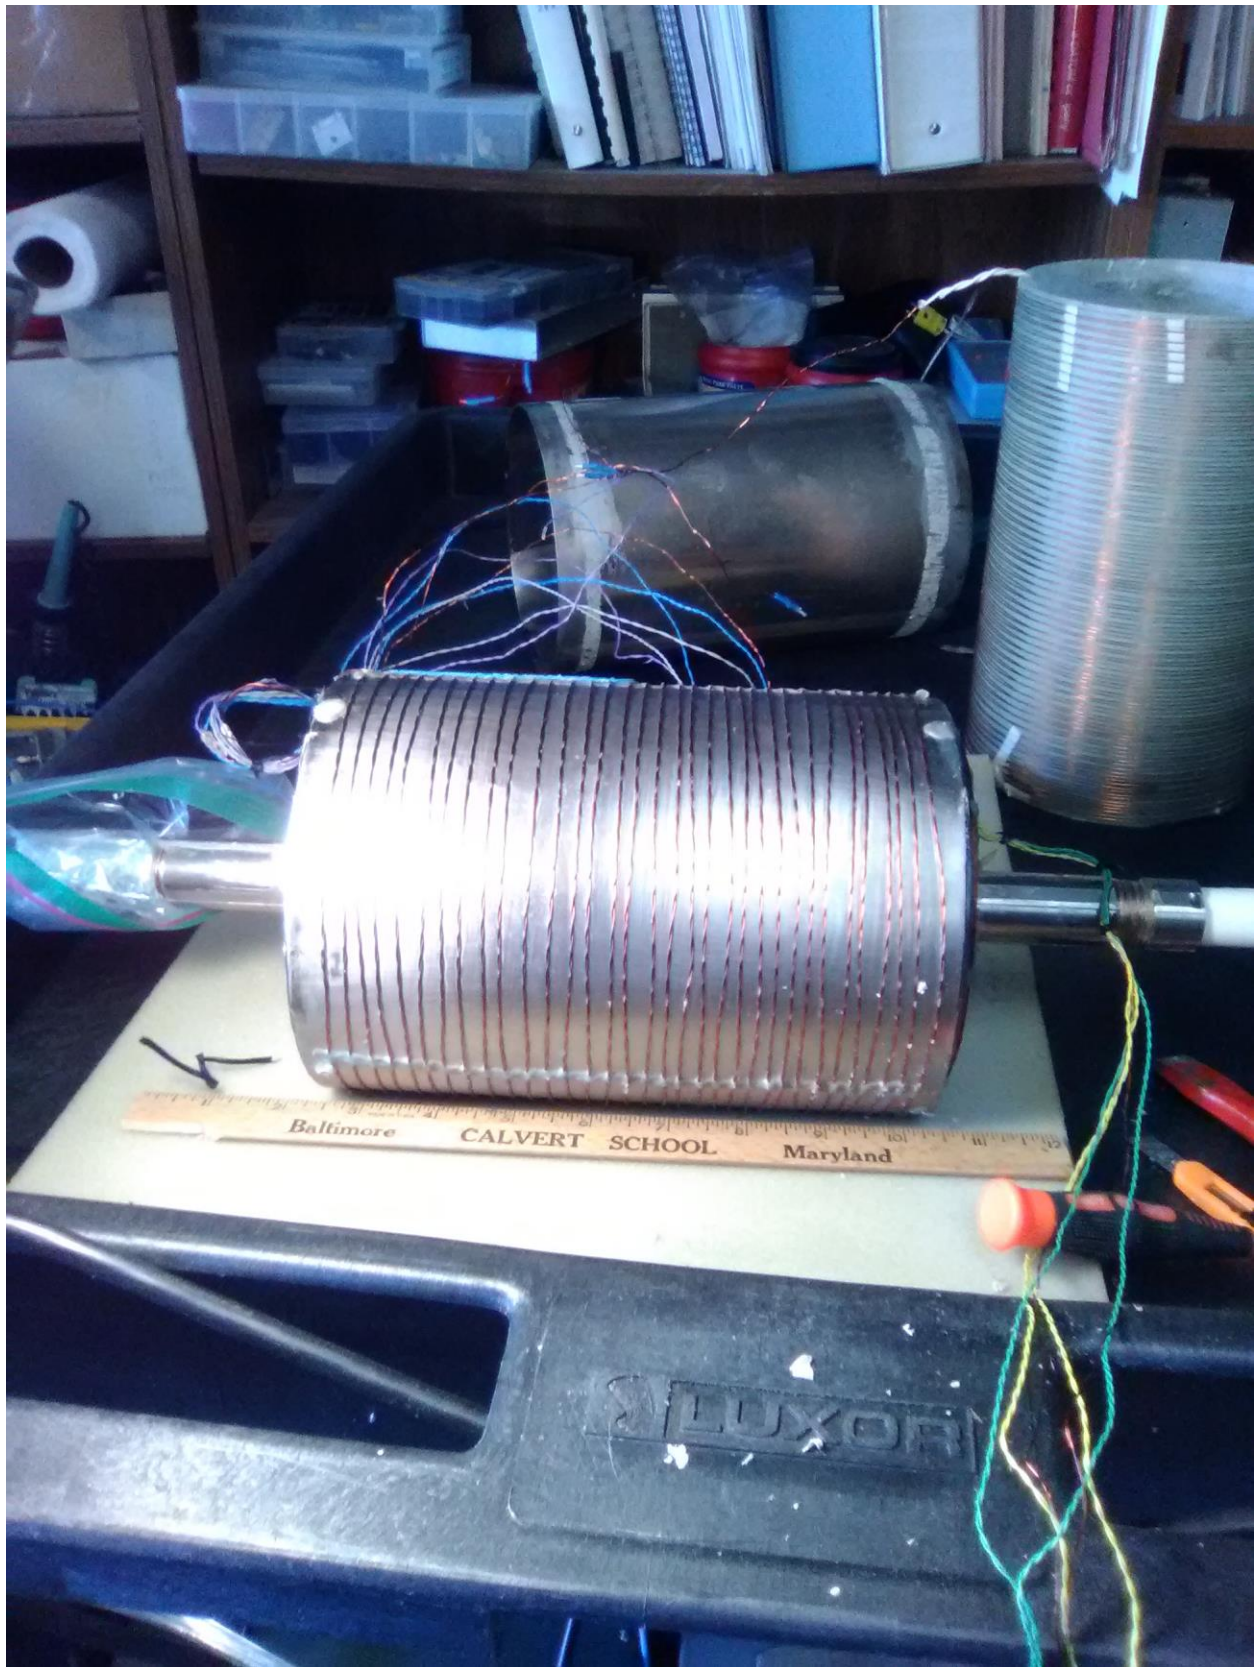
C-FIELD WINDING REMOVED. VACUUM ENVELOPE AND ITS HEATER FULLY EXPOSED.

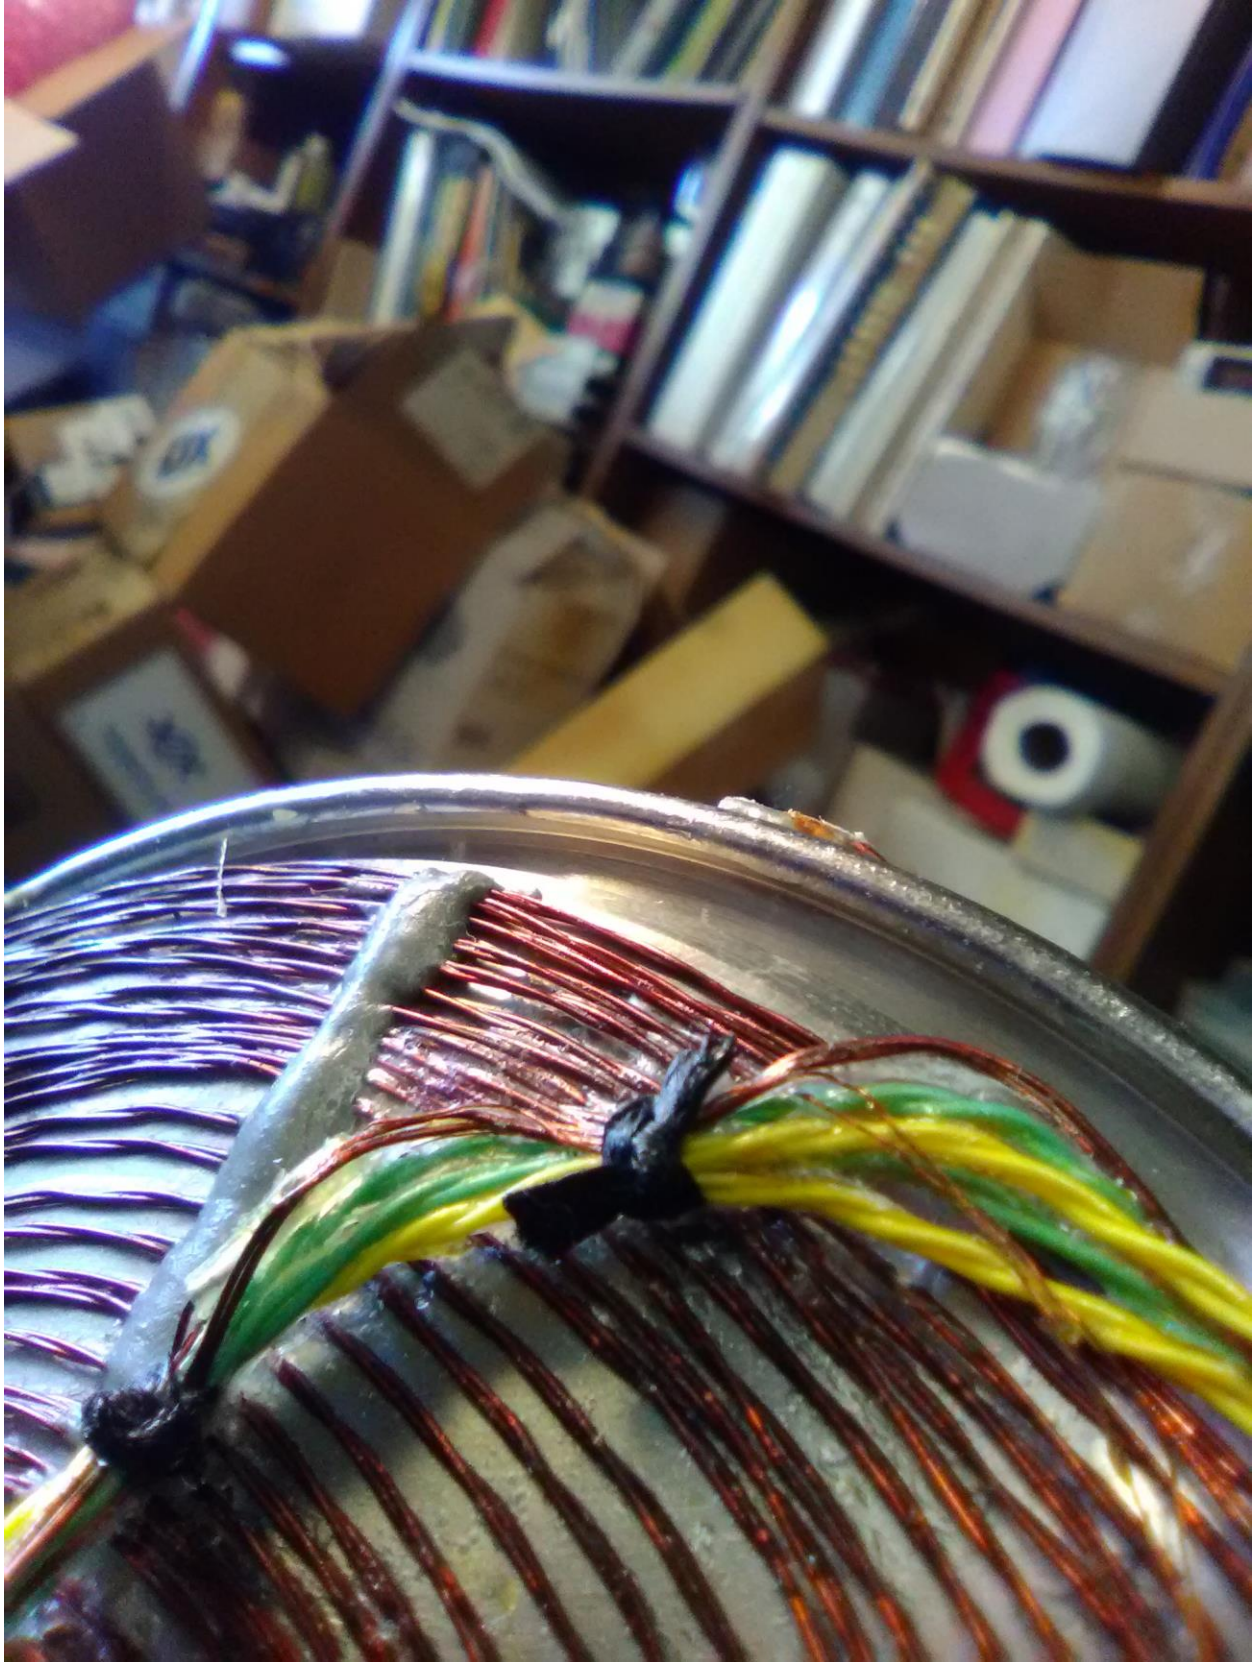
Unfortunately the "all welded titanium construction" of the vacuum envelope meant that getting it apart would require much cutting.

VACUUM ENVELOPE WELD

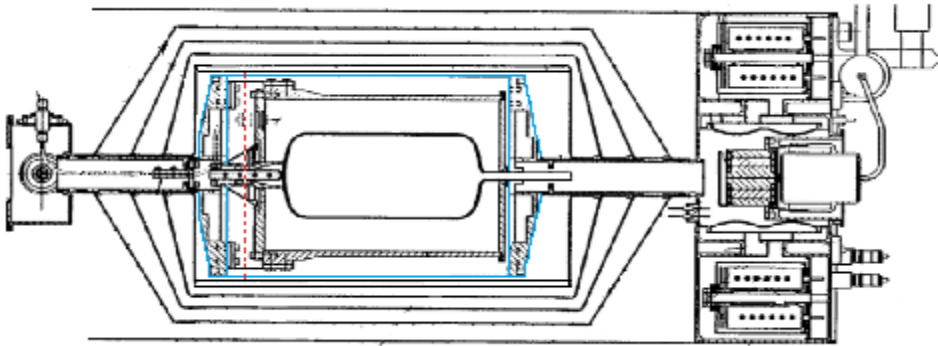
VACUUM ENVELOPE IN BLUE, PROPOSED CUT AT DOTTED RED LINE. SHOULD ALLOW CAVITY TO SLIDE OUT.

Details are not clear but it looks like (I HOPE) that the cavity is held onto the end plate of the vacuum enclosure with screws and also that the cavity end plate is also secured by screws. One reference says "cavity resonator is installed in the all Titanium vacuum chamber using Titanium leaf springs and Titanium screws."

Now all that remains is to figure out the best way, and the best location to open up the vacuum envelope.

Update six will detail getting the vacuum envelope open to expose the cavity, and opening the cavity to see if the varactor can be replaced.
